Arborist Report
Dana Point Harbor – Areas 1-16
City of Dana Point, Orange County, California

OC Dana Point Harbor
24650 Dana Point Harbor Drive
Dana Point, CA 92629
Contact: David Rocha, P.E.

Michael Brandman Associates
220 Commerce, Suite 200
Irvine, CA 92602
714.508.4100

Report Date: September 23, 2011

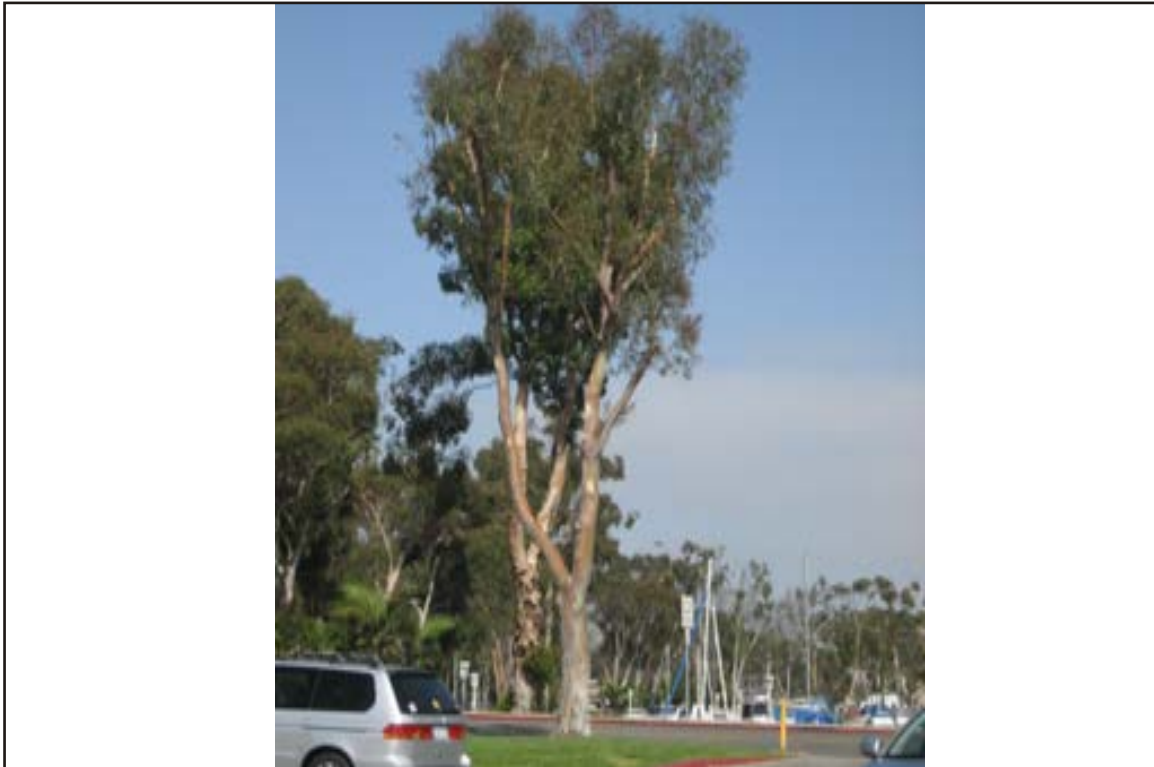
Photograph 2: Representative Red Gum Tree # 230 in Area 1.

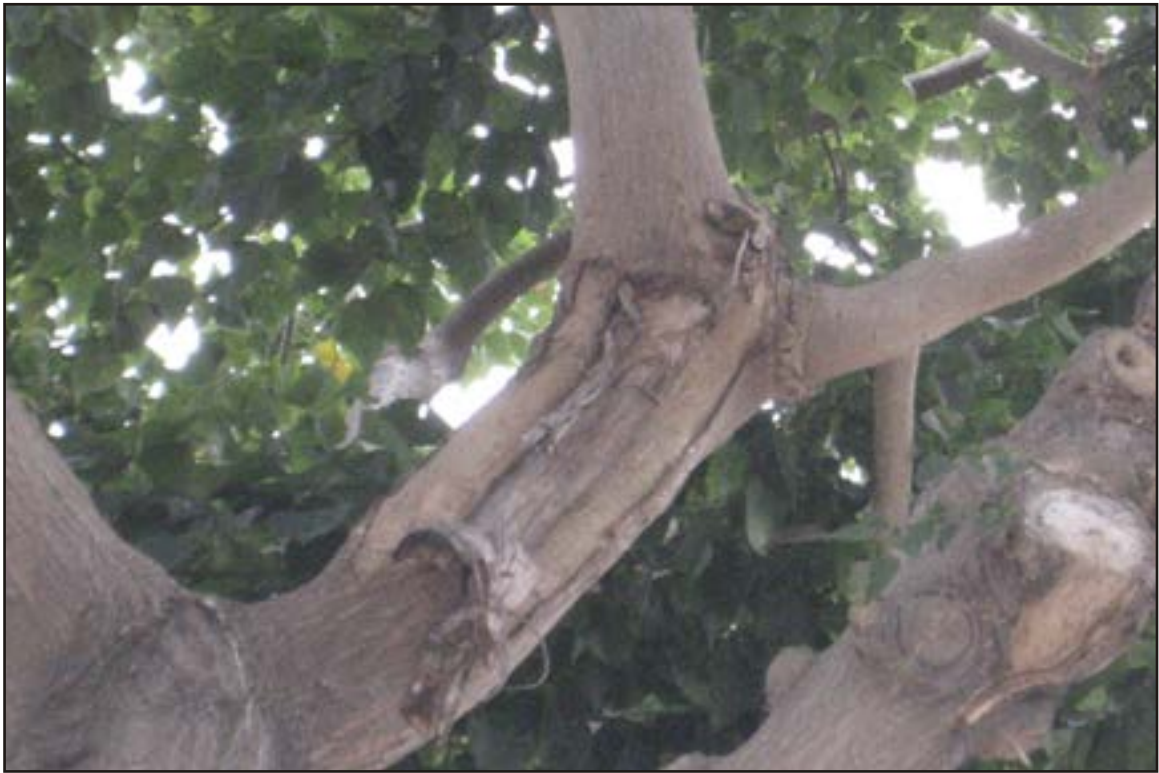
Photograph 5: Tree #101 in Area 2. Deetail of limb damage

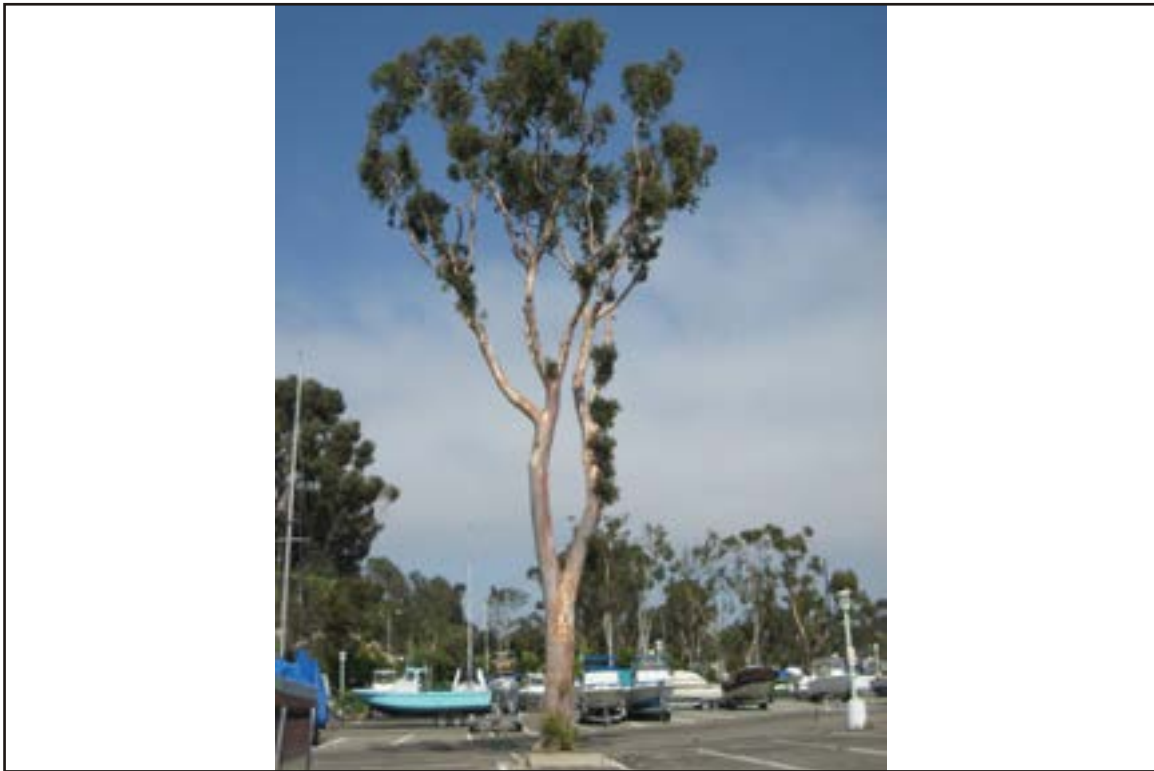
Photograph 7: Representative Sugar Gum Tree #133 in Area 2

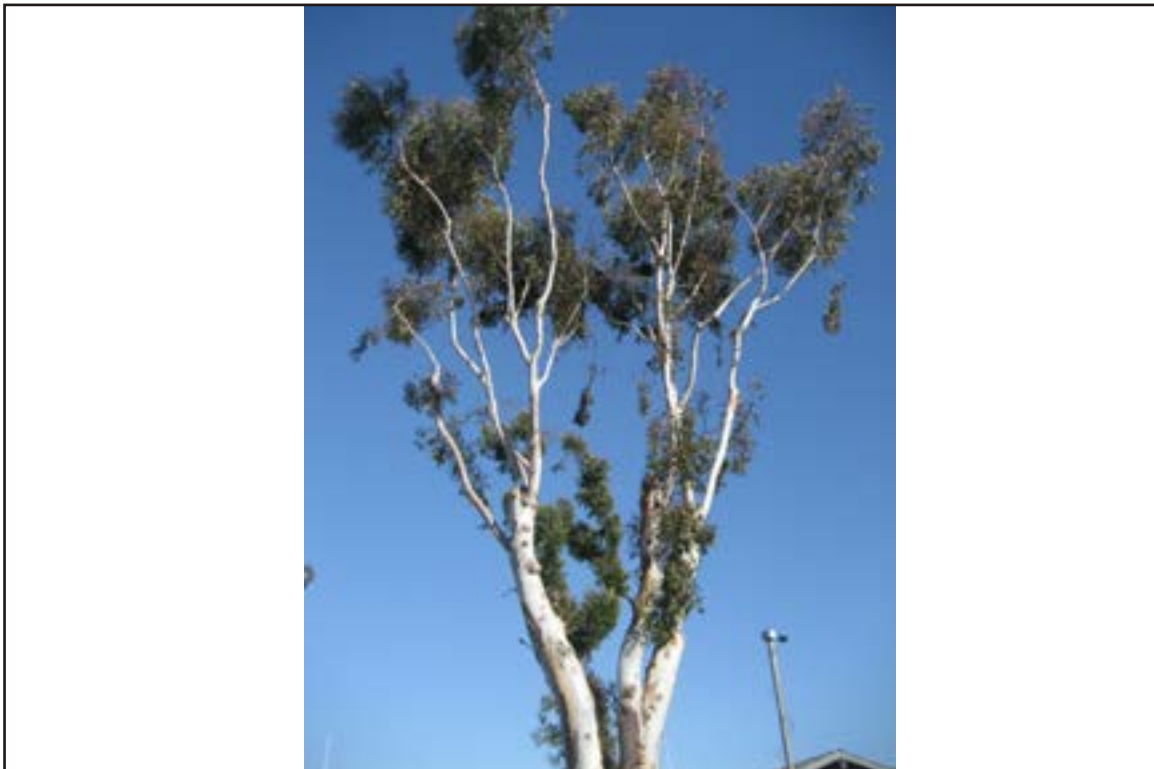
323	Spotted gum	<i>Eucalyptus maculata</i>	11.2	good	good	Mild crown die-back.
324	Sugar gum	<i>Eucalyptus cladocalyx</i>	18.3	good	poor	Some epicormic growth, severely unbalanced structure, causing cement damage.
326	Sugar gum	<i>Eucalyptus cladocalyx</i>	28.4	good	good	Causing severe cement damage.
327	Red-flowering gum	<i>Corymbia ficifolia</i>	10.5	good	good	
328	Sugar gum	<i>Eucalyptus cladocalyx</i>	16.0	fair	fair	Excessive epicormic growth, moderately unbalanced structure.
329	Red-flowering gum	<i>Corymbia ficifolia</i>	8.5	good	good	Somewhat unbalanced structure.
330	Red-flowering gum	<i>Corymbia ficifolia</i>	15.3	good	good	Somewhat unbalanced structure.
331	Spotted gum	<i>Eucalyptus maculata</i>	9.1	good	good	Leaf damage by ETB, some leaves curled, old would with exposed heartwood.

Photograph 10: Representative Sugar Gum Tree #326 in Area 3

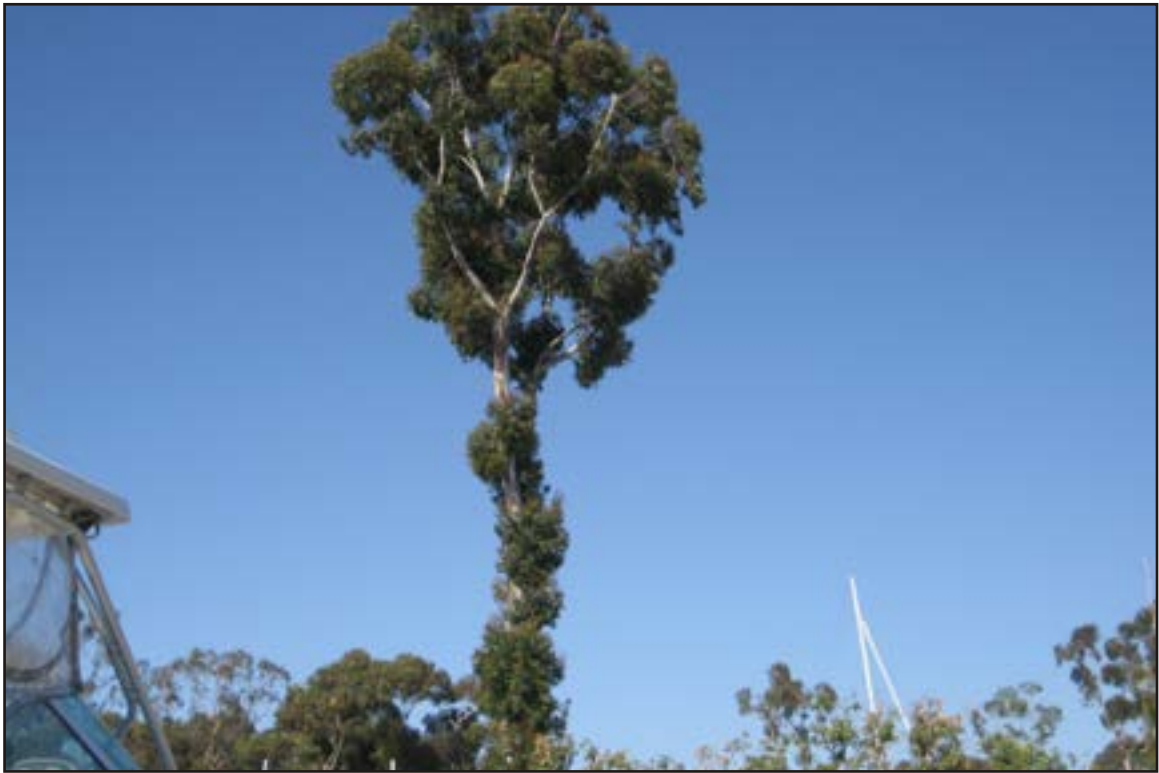
Photograph 11: Representative Spotted Gum Tree #323 in Area 3

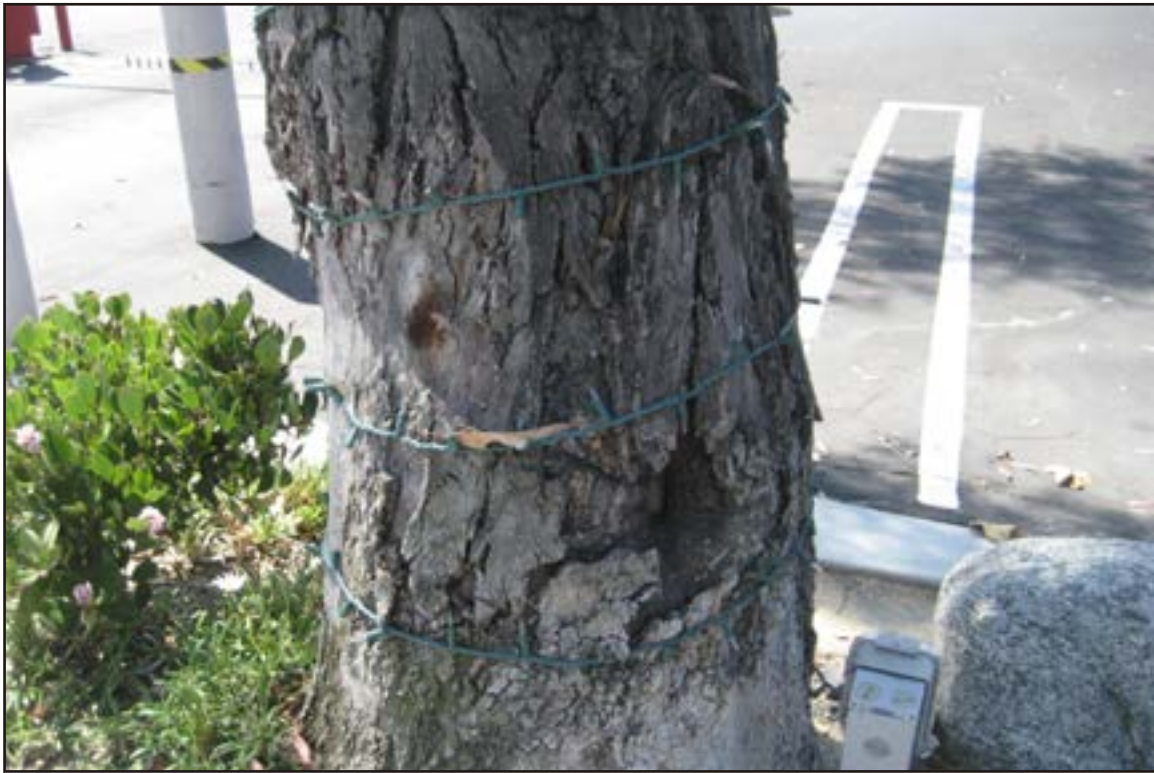
Photograph 13: Representative trunk damage on Tree #494 in Area 6

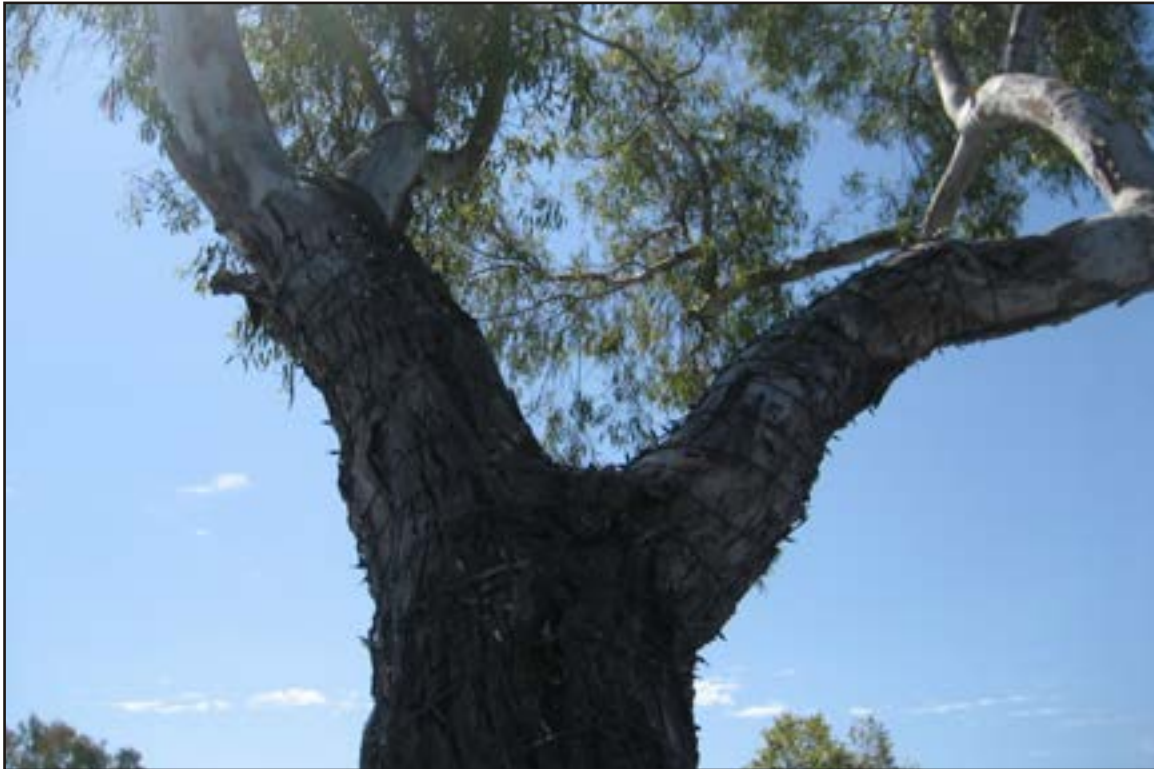
Photograph 14: Codominant trunks on Tree #494 in Area 6

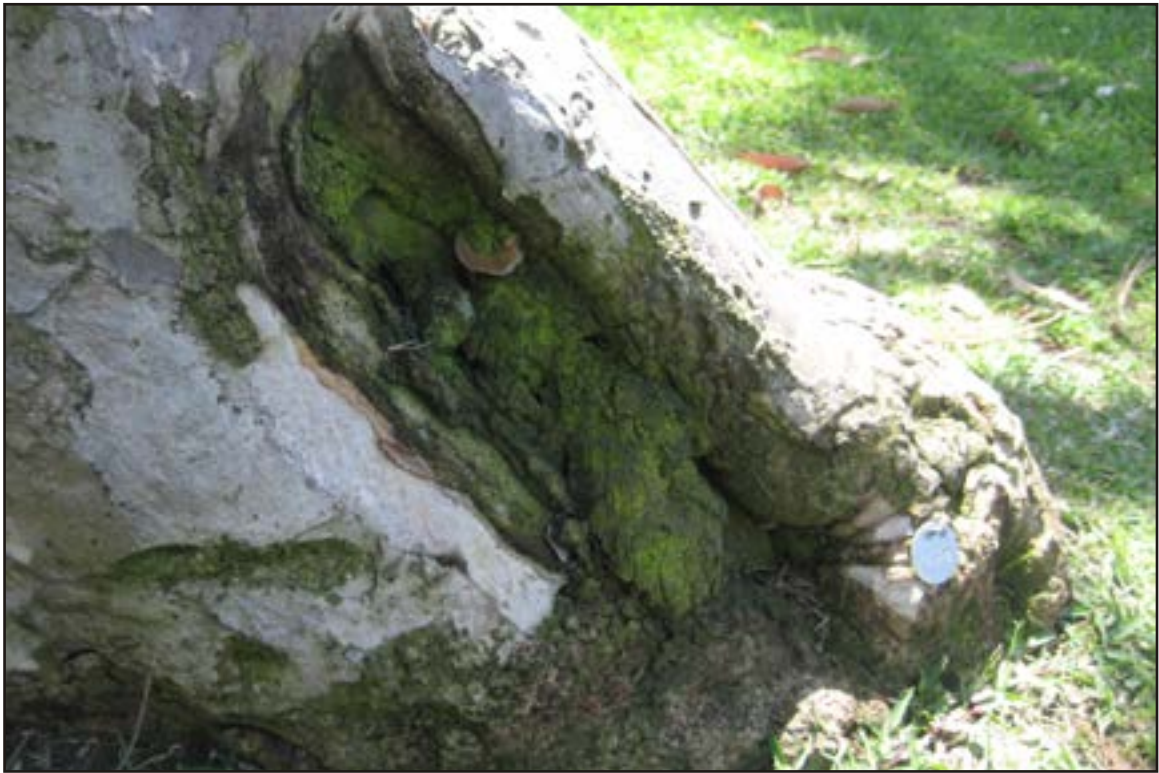
Photograph 23: Sugar gum Tree #589 detail of trunk damage, fungus, and algae due to excessive moisture
