**MARINE BIOLOGICAL FIELD SURVEY RESULTS
FEBRUARY-MARCH 2007, OCTOBER-NOVEMBER 2007,
AND JUNE 2010 SURVEYS**

**DANA POINT HARBOR MARINA IMPROVEMENT PROJECT
DANA POINT, ORANGE COUNTY, CALIFORNIA**

**Prepared for:
LSA Associates, Inc.
20 Executive Park, Suite 200, Irvine, California
Contact: Rob Balen
(949) 533-0666**

**Prepared by:
Coastal Resources Management, Inc.
PMB 327, 3334 E. Coast Highway, Corona del Mar, CA 92625
Contact: Rick Ware, Senior Marine Biologist
(949) 412-9446**

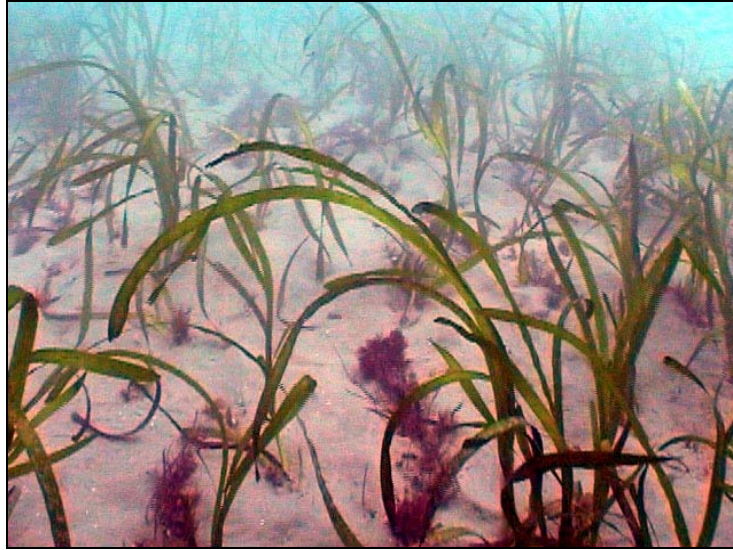
Figure 5. Eelgrass, *Zostera marina*. One “shoot” and the cluster of “blades” arising from the shoot is considered a “turion unit”.

Eelgrass (Figure 5) is a marine flowering plant that grows in soft sediments in coastal bays and estuaries, and occasionally offshore to depths of 50 feet (ft). Eelgrass canopy (consisting of shoots and leaves) enhances the abundance and the diversity of otherwise barren sediments. Many species of invertebrates (i.e., clams, crabs, and worms) live either on eelgrass or within the soft sediments that cover the root and rhizome mass system. Eelgrass is a nursery habitat for many juvenile fishes, including species of commercial and/or sports fish value (California halibut and barred sand bass). They are also foraging centers for seabirds such as the endangered California least tern that seek out juvenile topsmelt that are attracted to the eelgrass cover. Lastly, eelgrass is an important contributor to the detrital (decaying organic) food web of bays as the decaying plant material is consumed by many benthic invertebrates (such as polychaete worms) and reduced to primary nutrients by bacteria.
