The **COAST GUARD** Journal of Safety  
& Security at Sea  
**PROCEEDINGS**  
of the Marine Safety & Security Council

# The Marine Casualty Investigation Process

***Connecting the Dots***

***Examining the  
causal factors that  
lead to marine casualties***

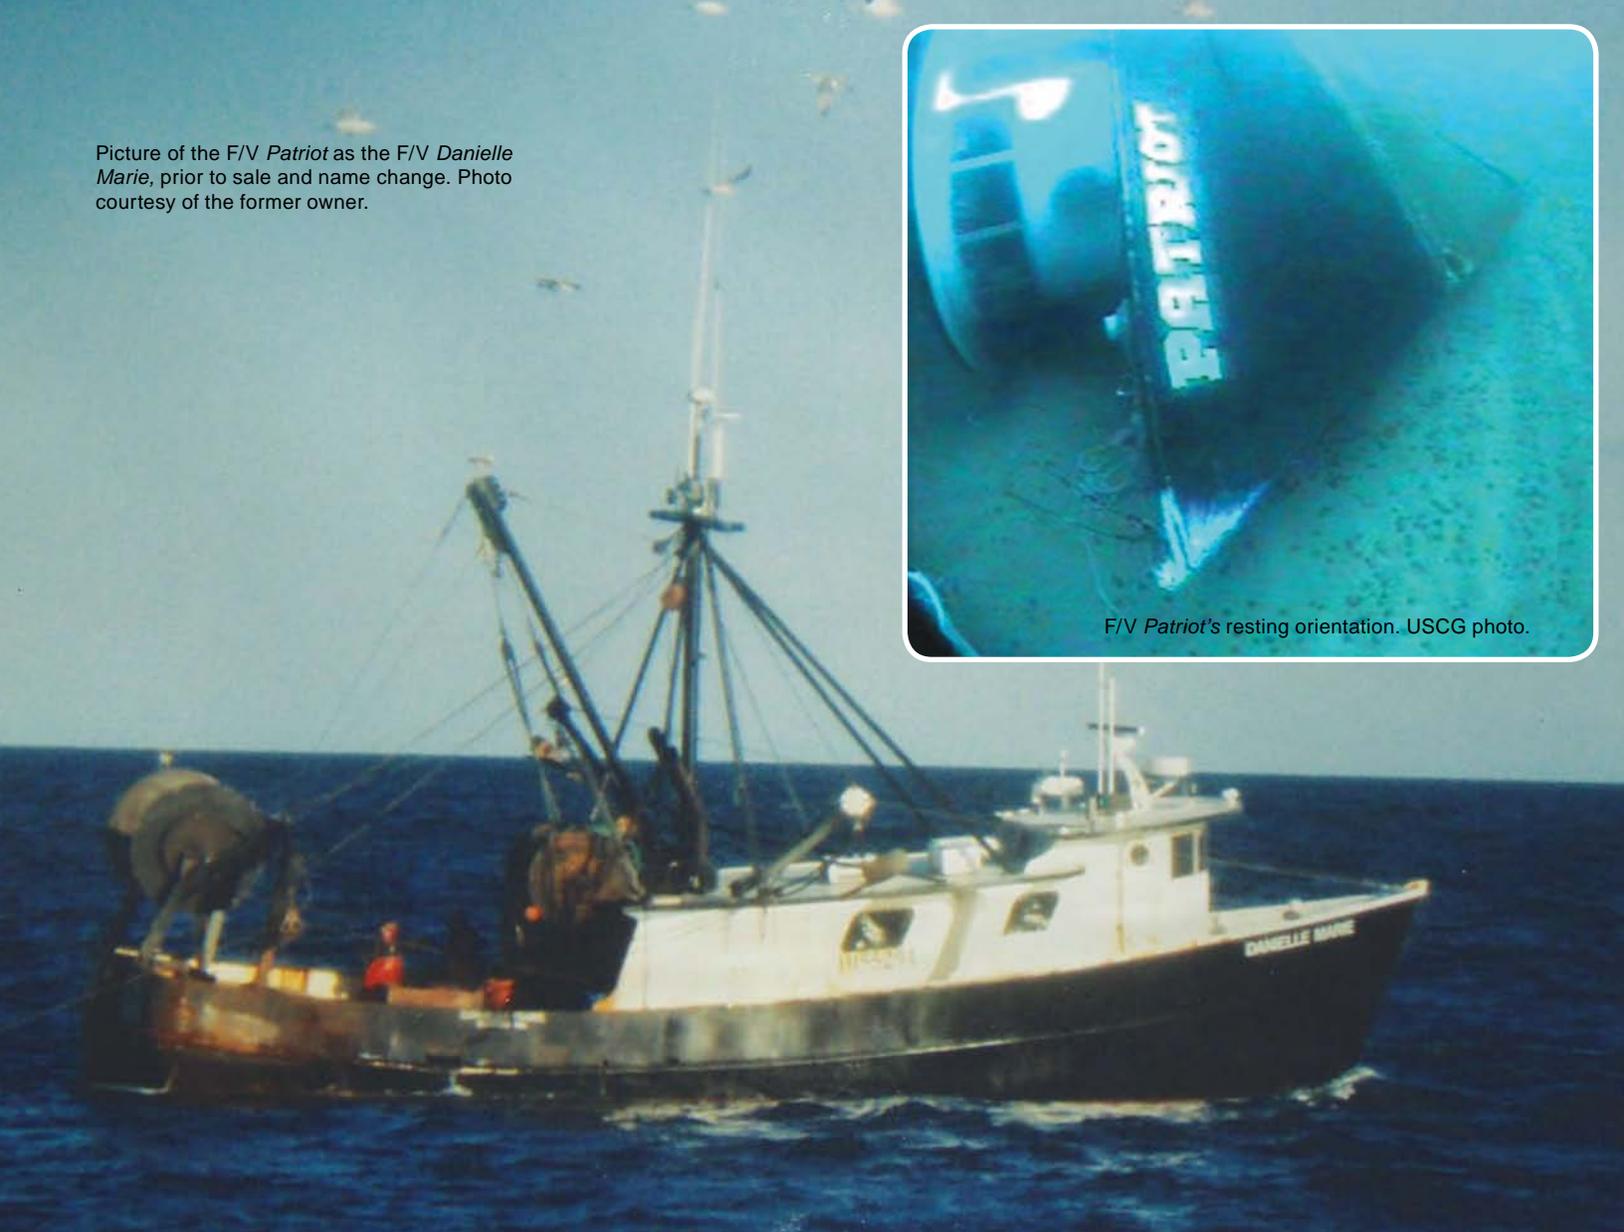
F/V *Patriot*'s resting orientation. USCG photo.

Concurrent to this effort, a remotely operated vehicle underwater survey confirmed the vessel was in approximately 100 feet of water, and revealed the vessel was lying on its starboard side with its fishing nets in a retrieved position. There was no evidence of a fire nor any visible damage to the hull or superstructure.

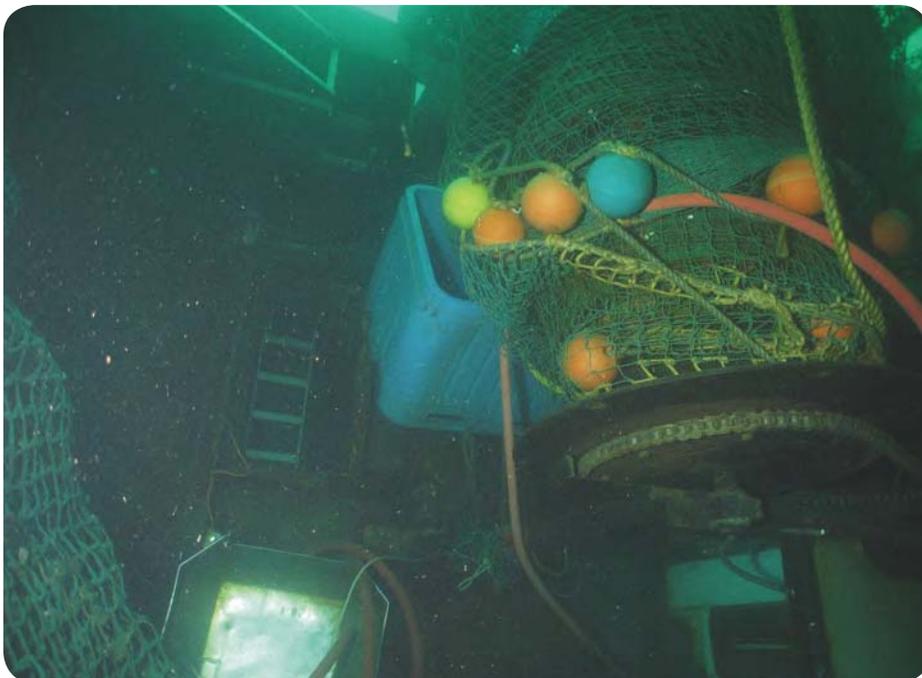
The vessel's wash-down hose was found entangled in the forward net reel. USCG photo.

This entangled wash-down hose may explain the speed decrease noted in the auxiliary motor at 1:06 a.m., and its increase at 1:09 a.m. Interviews with a former owner and vessel crew members established that the auxiliary motor the analysts heard is likely the vessel’s wash-down pump.

This hose entanglement would have increased the wash-down pump’s flow resistance and caused the motor’s speed to decrease. The diesel engine speed decreases at 1:08 a.m. and at 1:09 a.m., the auxiliary motor speed begins to increase again. This 1:09 a.m. increase may have been the crew diverting system’s flow or a hose/connection bursting, relieving pressure and resistance on the wash-down pump. This loss of resistance would cause the motor speed to increase from 1:09 a.m. to when the auxiliary motor noise was lost at 1:12 a.m.

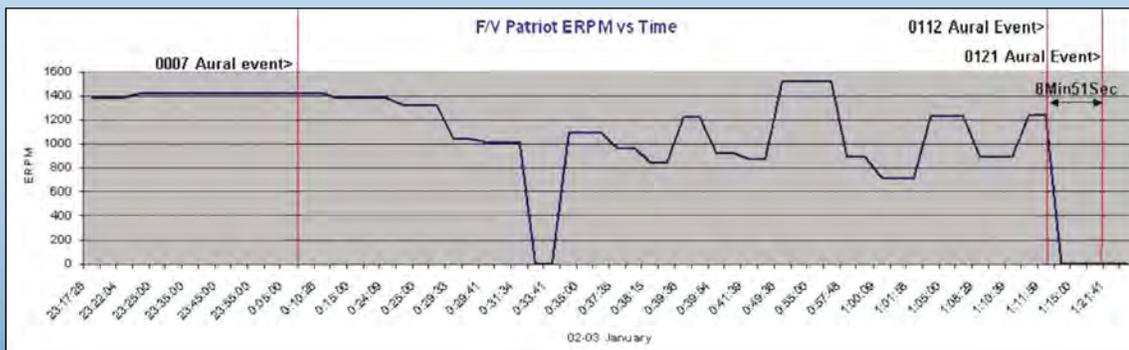
F/V *Patriot* engine rpm vs. time, with a red line corresponding to each aural transient event. Notes: On this chart, an rpm reading of 0 means engine noises quieted to an undetectable level, not necessarily that the engine was shut down; 0.0001 nautical mile error radius. Chart courtesy of U.S. Navy CUS.

Analysis of ATE 1 found that the event was made up of a series of individual sounds. The first sound in this series had the aural characteristics of a metal-on-metal impact. At least 12 short pulses follow this sound in groups of three at regular interval of 9.60 pulses per second, which matches the rotational rate of the tugboat's propeller. ATE 1 could not be definitively explained, but it is most likely propeller cavitation or an object striking the tugboat's propeller.

Analysts described ATE 3 a series of seven irregular, quiet sounds lasting two seconds total with the final and loudest sound having a hollow metallic quality. Because ATE 3 is only heard on buoy 4, Cornell location analysis was not possible. No further sounds associated with the F/V *Patriot* are heard after this point; ATE 3 is most likely the sound of the vessel hitting the ocean floor.

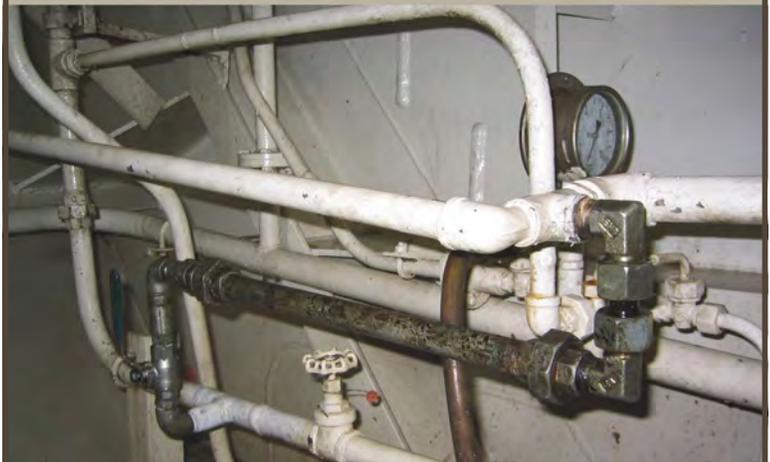
An example of an installed bypass used for deliberate discharges.

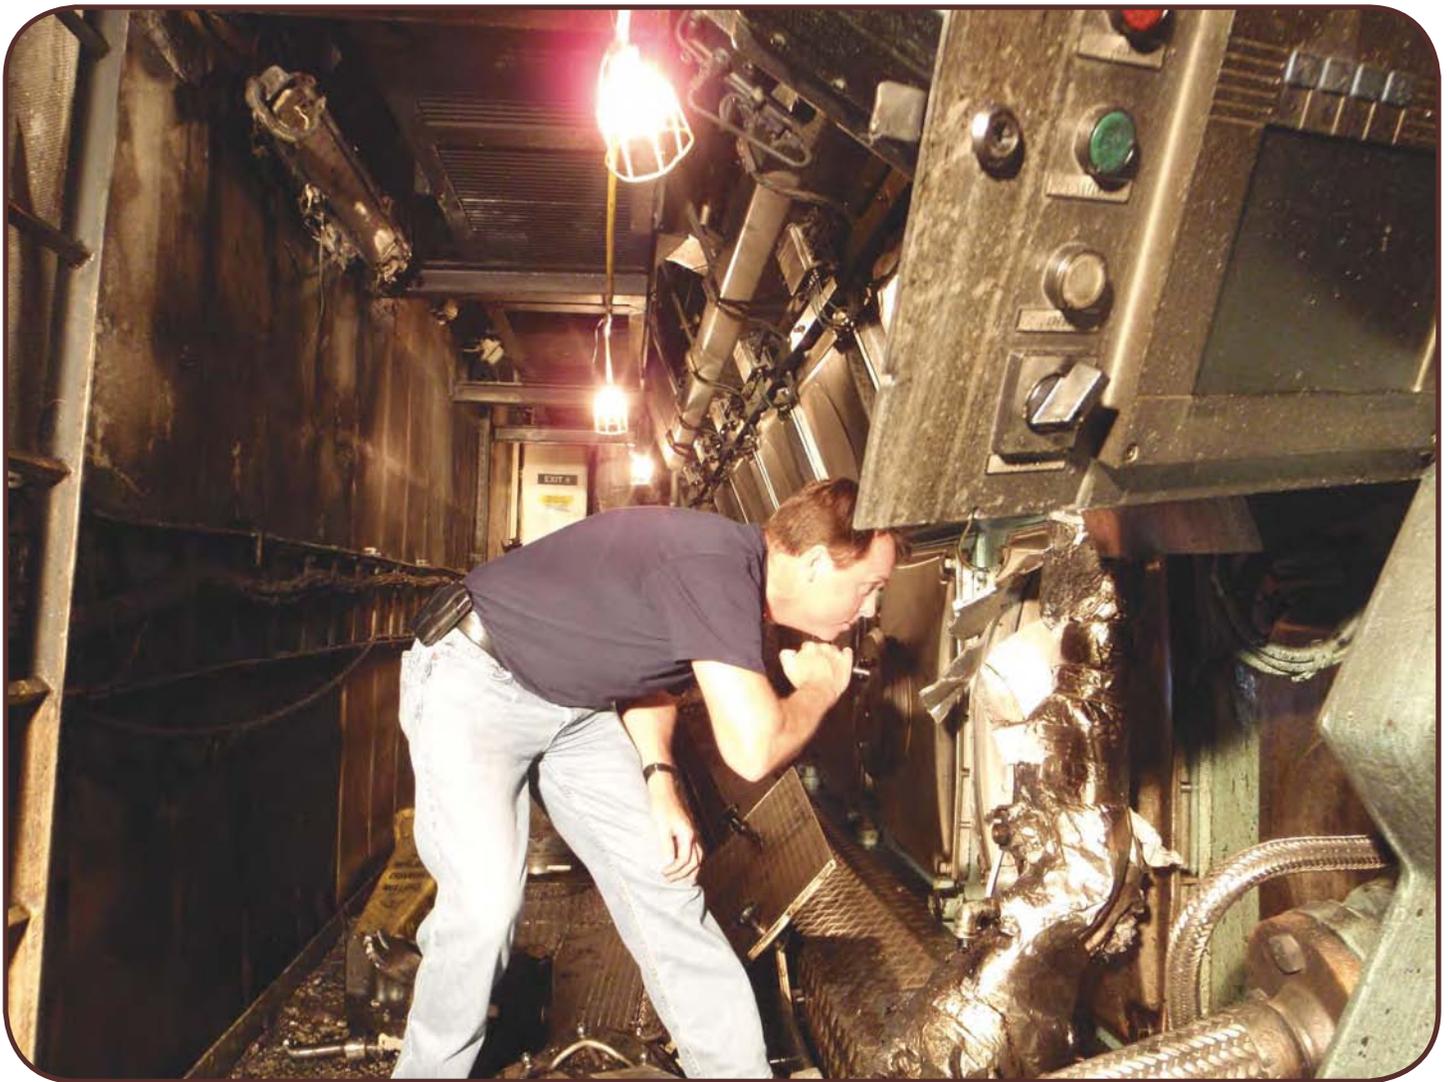
0 U3DMFN&XW ,1 &2 ( VHQRUP DUCHIQYMM DRUH DP LQVHQJLQURRP GDP DJHROZ IQJ D;UHRCERDUGVHFUXLVHVKIS *Carnival Splendor*. He also aided in the forensic examination of the failed engine components. All photos USCG.

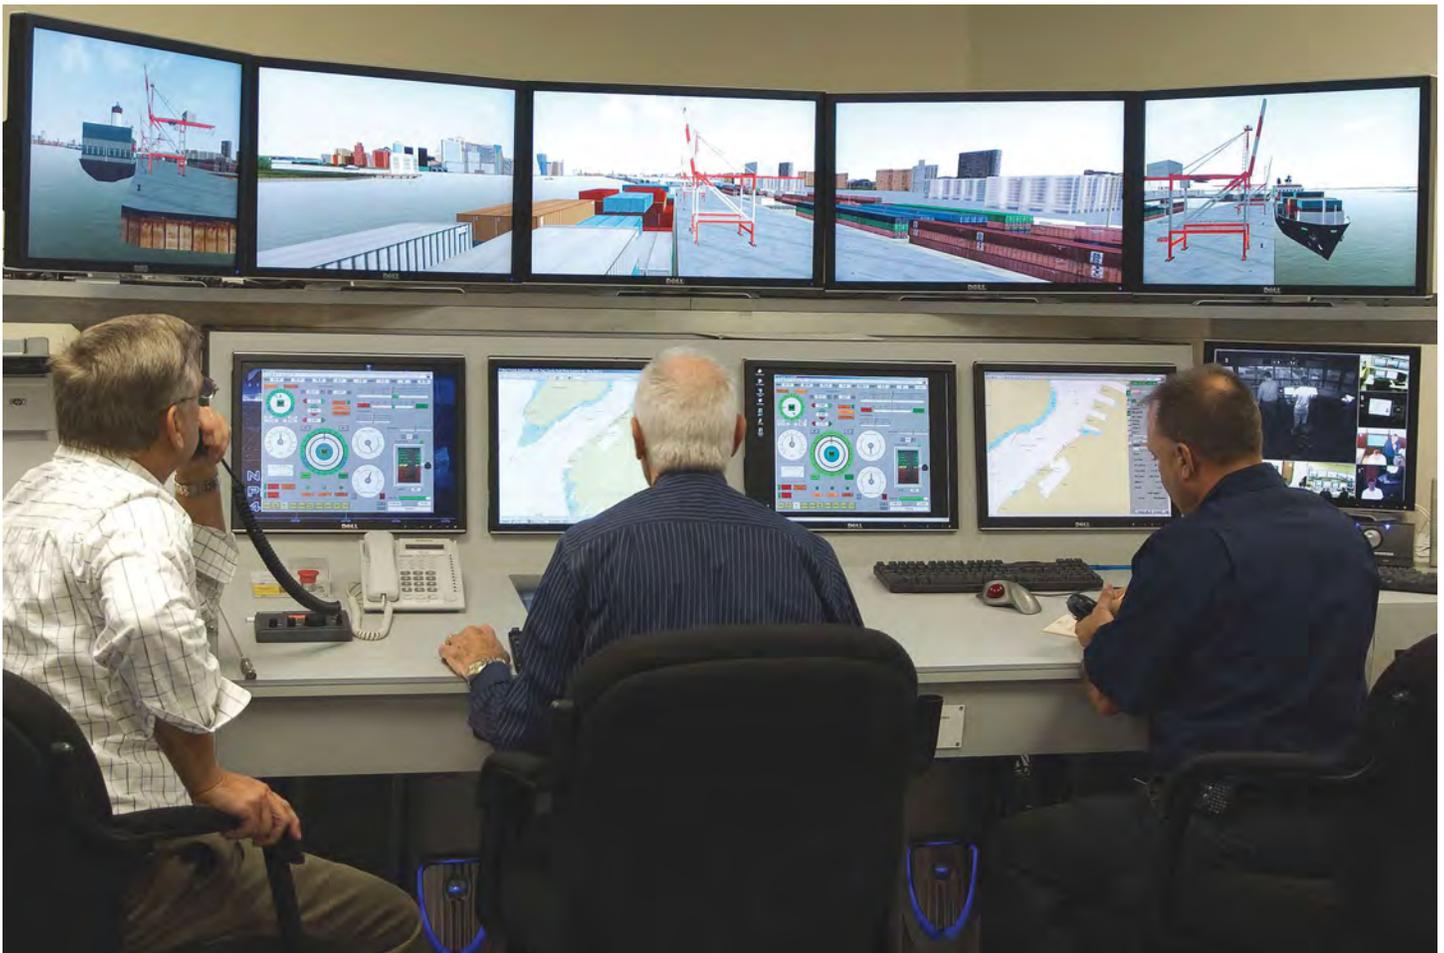
Course instructors at the control console for the MITAGS simulator. The personnel in the center maneuver the vessel and respond to the simulation, while the instructors control the scenario. Photos courtesy of the Maritime Institute of Technology and Graduate Studies.

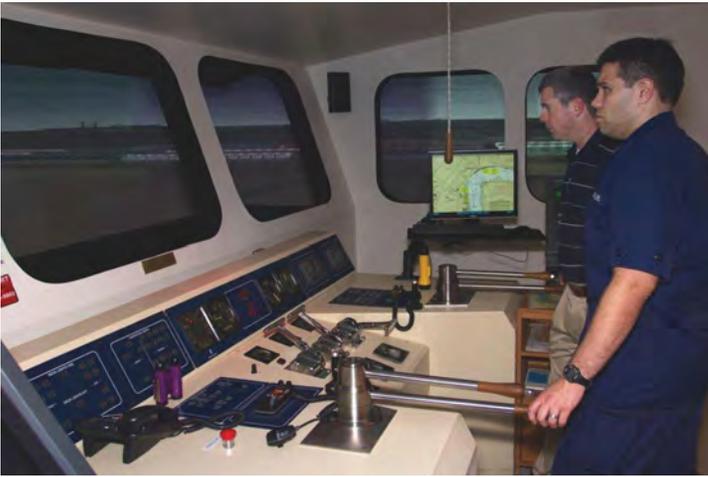
LT Chris Jones is at the tiller sticks in the simulator towboat wheelhouse. CAPT Stephen Polk, SCI Houston, coaches him on the unique maneuvering characteristics of the vessel. Photo courtesy of Mr. Matthew Hyner, SCI's Center for Maritime Education in Houston, Texas.

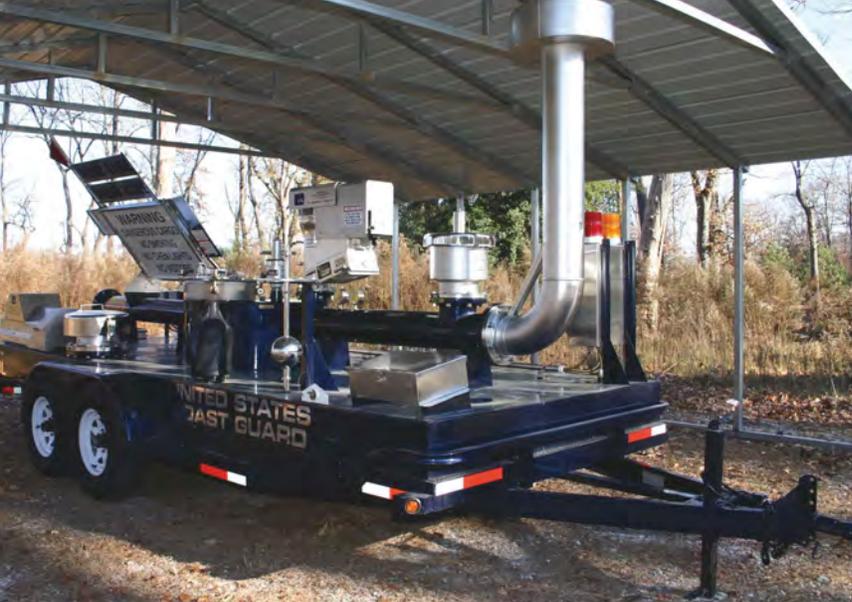
7KLVQHZ EDUJHIVIXO RXVWVWGZLKDQMSHVRI YDQYHV JDXJLQJ DCGSROXWRO SUH-  
vention equipment, and can be towed to different areas for display training oppor-  
tunities. All photos USCG.

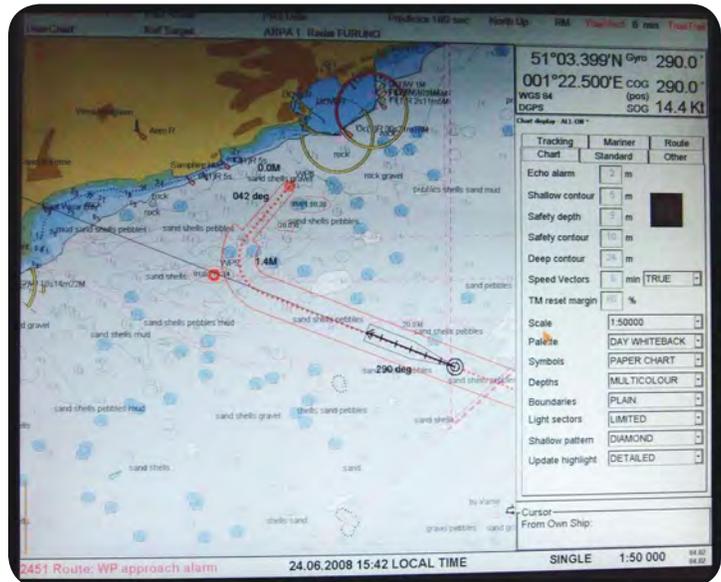
Screen capture taken from an electronic chart display and information system unit depicting an intended passage plan of a vessel. Photos on this page courtesy of Richard North, technical manager, UK Marine Accident Investigation Branch.

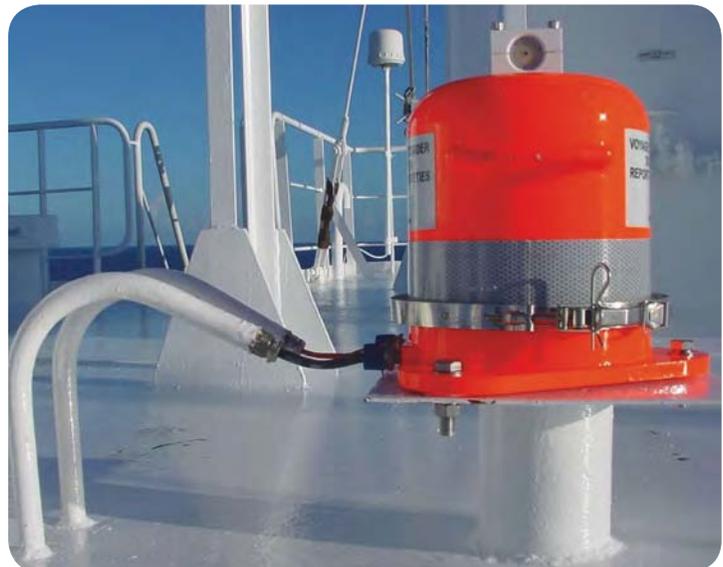
Image of an installed voyage recorder.

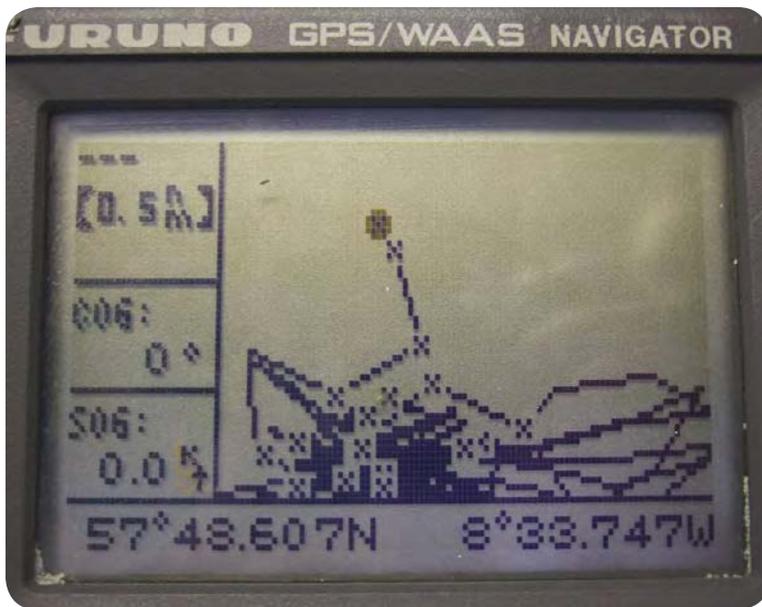
Screen of early GPS/Wide Area Augmentation System Navigator. Photo courtesy of Richard North, technical manager, UK Marine Accident Investigation Branch.

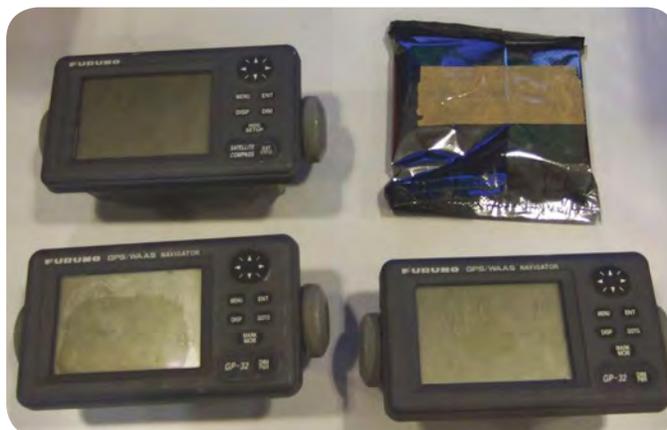
Traditional Global Positioning System equipment. Photo courtesy of the UK Marine Accident Investigation Branch.

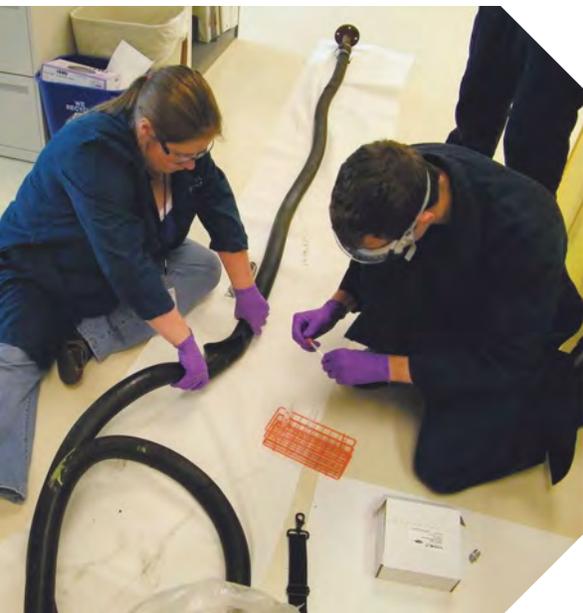
A Marine Safety Lab forensic chemist and technician work to extract a sample from a hose suspected of being used to bypass an oily water separator. USCG photo.

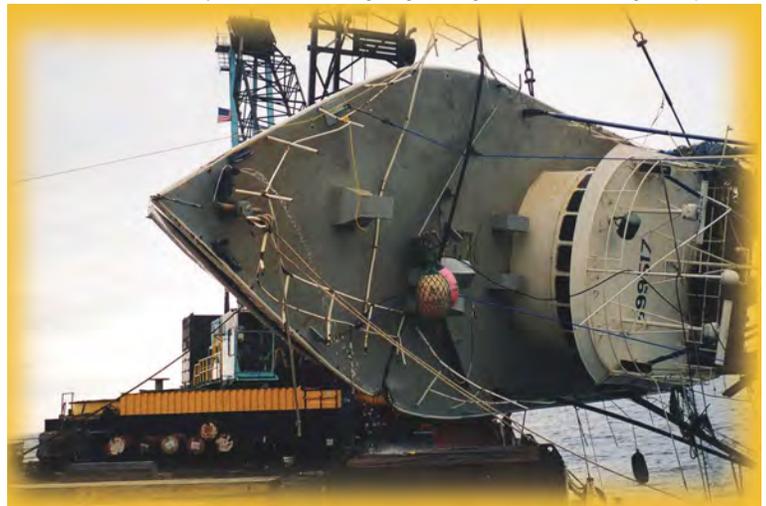
On Jan. 26, 2007, the commercial fishing vessel *Lady of Grace* sank in the Nantucket Sound during severe winter weather conditions, while transiting to New Bedford, Mass. The vessel was located submerged in approximately 56 feet of water, resting on its port side. Of the four crewmembers aboard, two were recovered

CFV *Lady of Grace* undergoing salvage. USCG investigation photo.

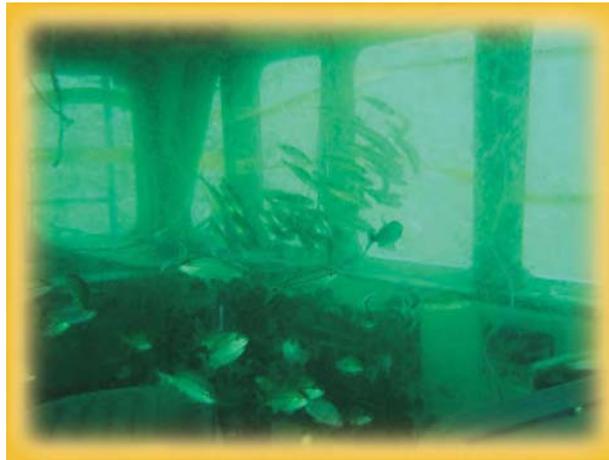
The UTV *Valour* rests underwater, prior to salvage. USCG photo.

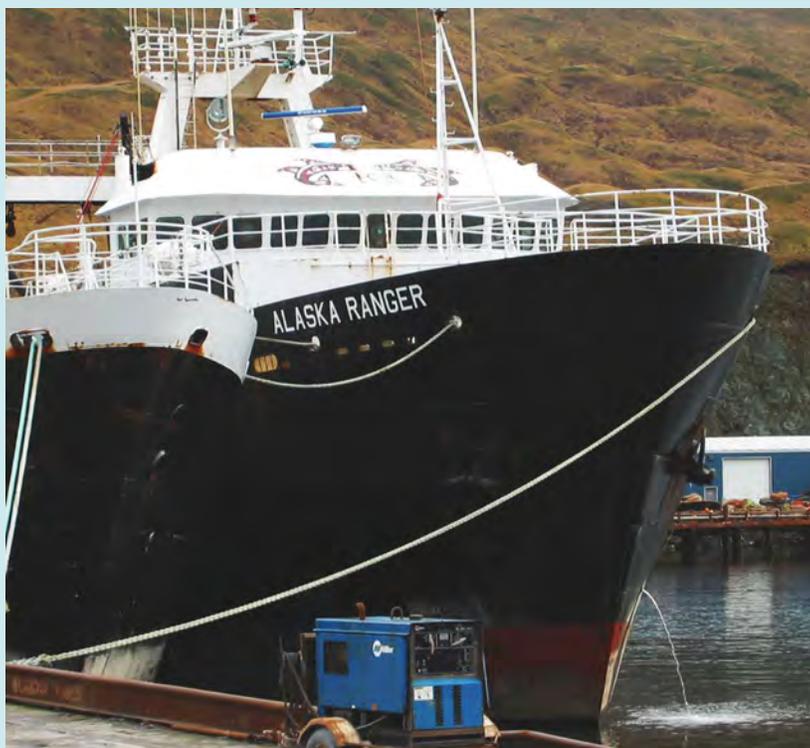
The main deck (factory deck) was above the hold deck. Entrances to the factory included two watertight doors in the aft bulkhead as well as a ladder, port side forward, leading up to the interior of the shelter deck. The ramp room (N) had port and starboard watertight doors that

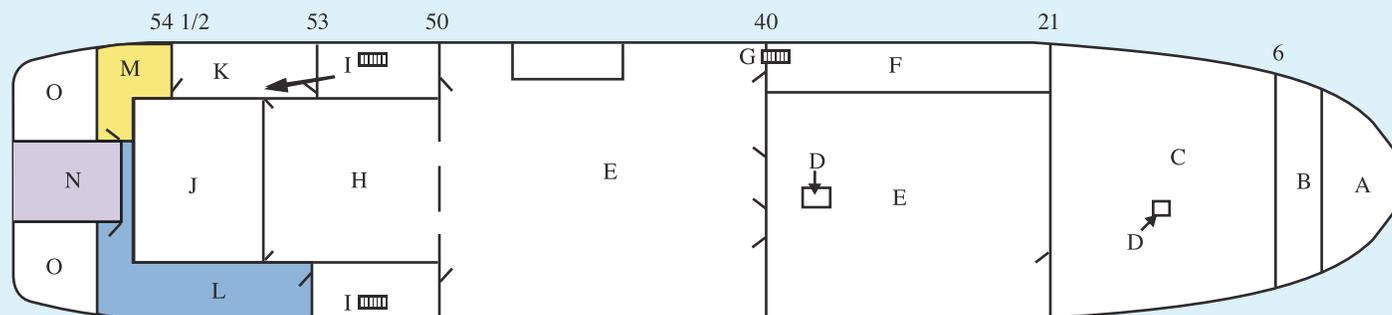
opened to harbor generator room (M) and starboard work shop (L), respectively. Between the ramp room and the number four freezer hold (J) was a small, narrow space open on the starboard side and enclosed on the port side with a bulkhead.

| A – Forepeak Tank | I – Ladder Wells |

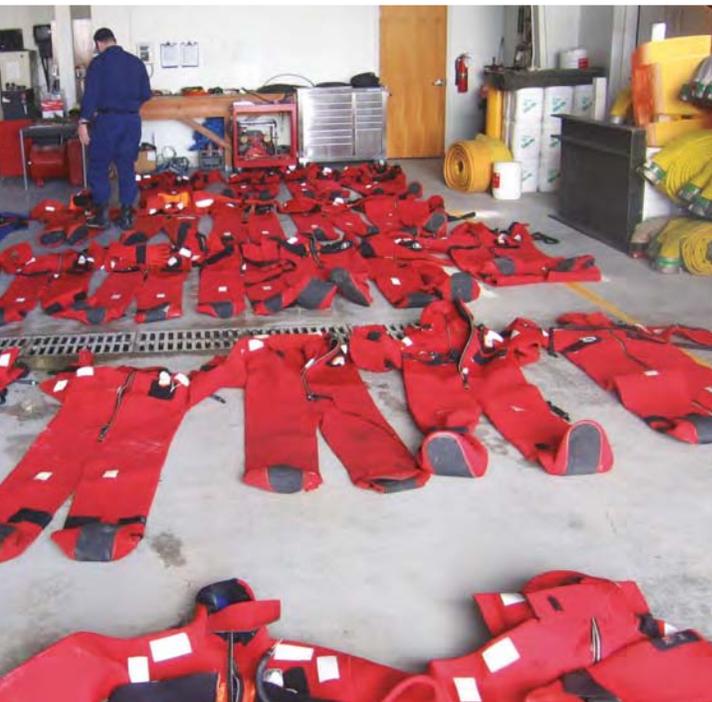
Immersion suits used by the vessel's crew, undergoing inspection during the investigation process.

Not all of the crewmembers aboard the vessel had received survival suits that were the correct size. In fact, several of the smaller crewmembers received suits that were too large, allowing excessive water to enter the suit. Two crewmembers testified that their suits contained water or damage before they donned them. In addition, the captain had donned a "jumbo" immersion suit even though he was relatively small. There was water found in his suit when the USCG helicopter crew picked him up. The survival suits of the mate, along with three unconscious hypothermic survivors, also had water in their suits and were likely too large.

The U.S. Coast Guard Commercial Fishing Vessel Safety Examiner, who conducted the vessel's last exam, testified that all the survival suits onboard the vessel were in satisfactory condition, with the exception of several that were more than 10 years old. He required the vessel's owners to replace the older suits in January 2008. Regulations require the master in charge of a vessel to ensure all lifesaving equipment is in good working order, ready for immediate use, and readily accessible before the vessel leaves port and at all times when the vessel is operated. The Marine Board of Investigation inspected all of the suits after the casualty and found them in acceptable condition.
