The **COAST GUARD** Journal of Safety  
& Security at Sea  
**PROCEEDINGS**  
of the Marine Safety & Security Council

***100 Years of  
Marine Safety***

Summer 2012

Vol. 69, Number 2

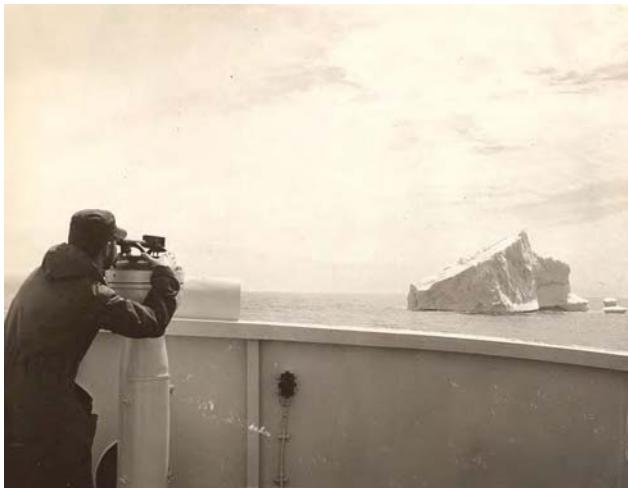
USCGC *Androscoggin* crewman gathers information on an iceberg near the Grand Banks of Newfoundland. USCG photo.

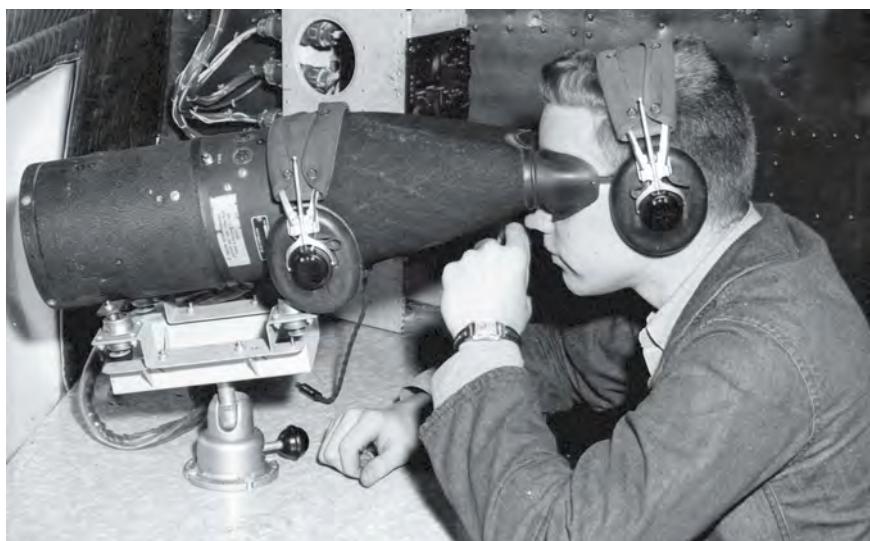
Radar operator aboard the USCG R5D-3 aircraft. USCG photo.

With the advent of shipboard radars during World War II, in 1946, U.S. Coast Guard Cutter *Mojave* was equipped with a 10-cm radar and 3-cm radar. (The numbers refer to the wavelength of the microwaves the radar transmits.) In general, longer wavelength radars have poorer resolution than short wavelength radars, but are less affected by sea clutter.

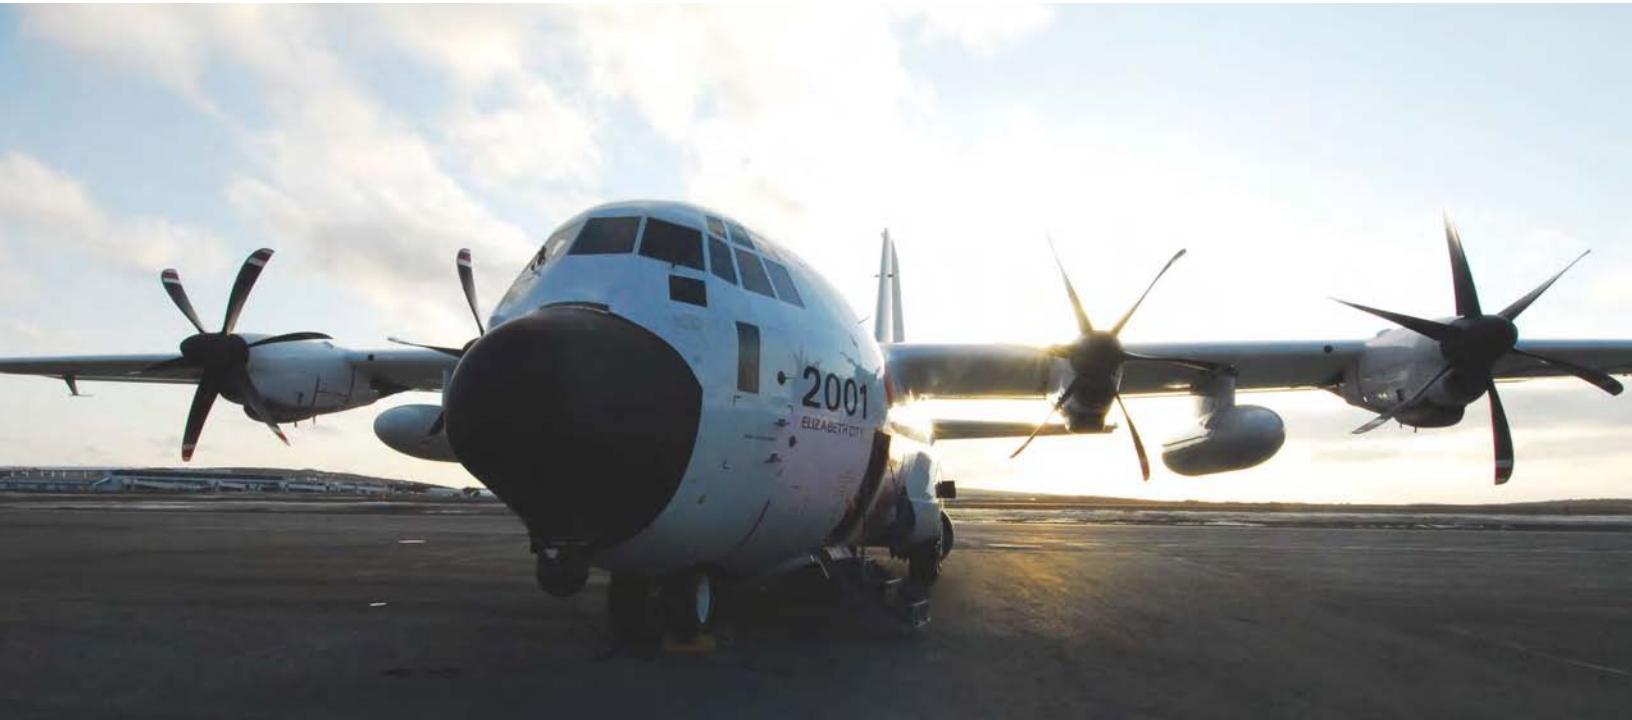
IIP's primary aerial reconnaissance platform is the C-130J, shown here in St John's, Newfoundland. USCG photo by PAC Robert Laura.

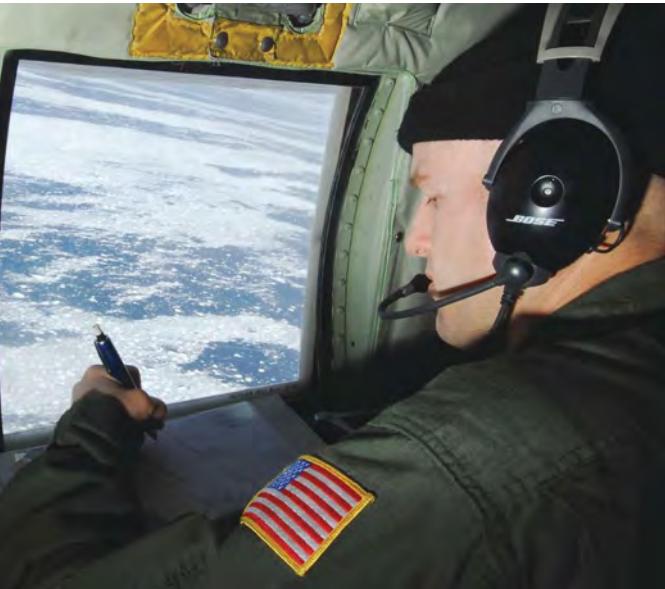
An ice observer records iceberg sighting information. USCG photo by PAC Robert Laura.

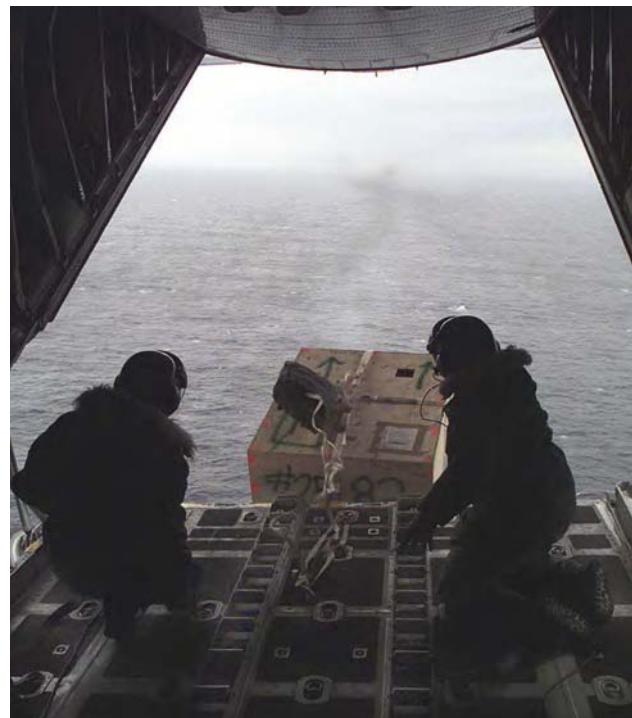
Aerial deployment of a World Ocean Circulation Experiment buoy, used to monitor ocean currents responsible for iceberg transport. USCG photo.

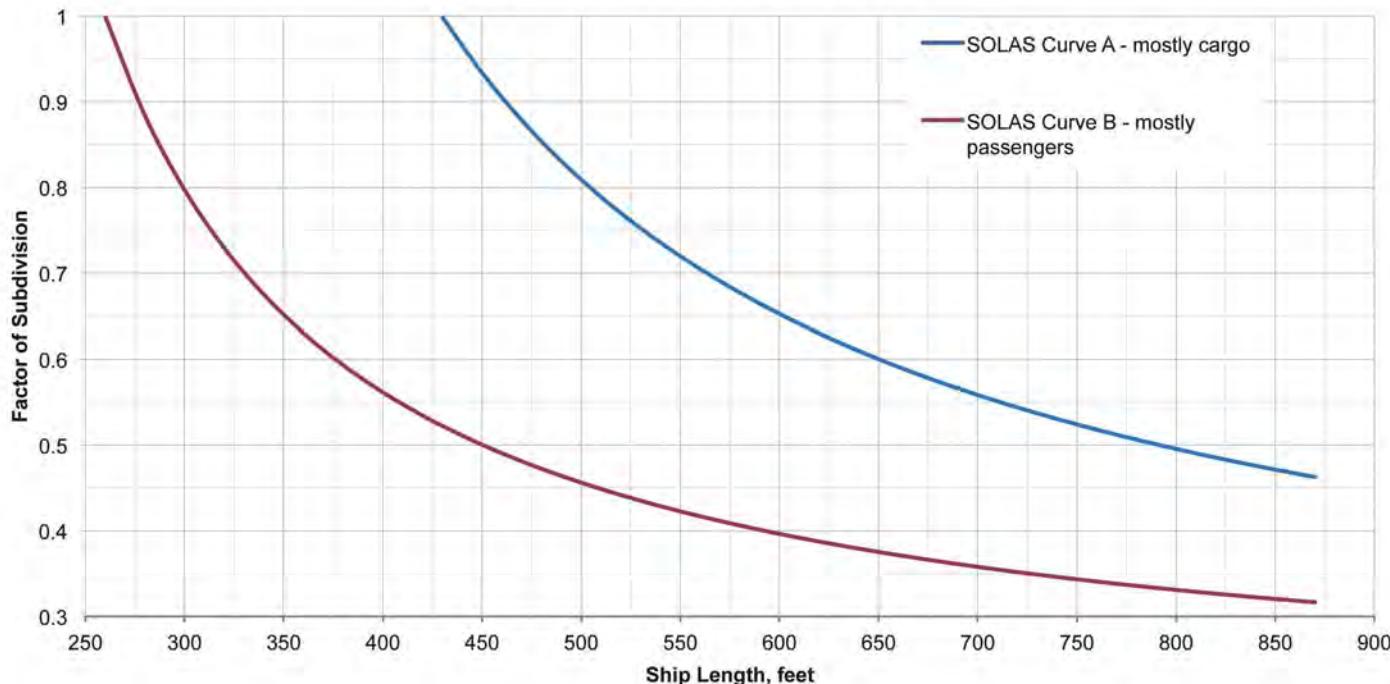
### SOLAS Factors of Subdivision

by the British, was adopted to categorize a ship as "mostly passenger" if the volume of space in the hull below the margin line was mostly devoted to passenger spaces (passenger spaces above this line were not accounted for). If  $C_s$  was less than 23, the ship was deemed to be carrying mostly cargo, and Curve A was used; if greater than 123, the ship was carrying mostly passengers, and, if in between, an interpolated factor of subdivision between the two curves was calculated.

based on the fixed permeabilities proposed by the British, the fixed margin line proposed by the Germans, and a factorial system proposed by the French.

Early 20<sup>th</sup> century ships were designed to carry a mix of passengers and cargo and all generally had the same hull form. Even the *Titanic* was designed to carry cargo, and a factorial system using two simple formulas was set up to reflect this (see graph).

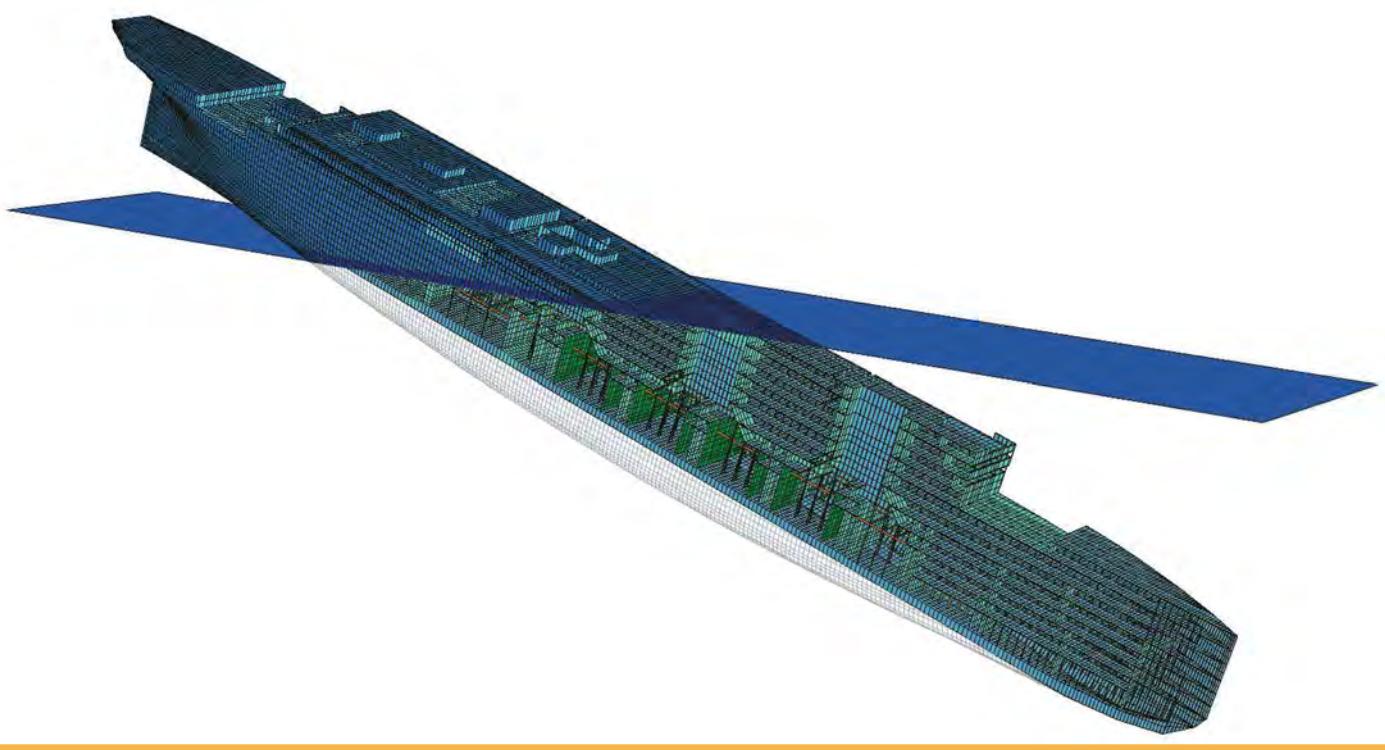
Finite element model of the *Titanic* showing the orientation when break-up could have occurred. Graphics courtesy of Cmdr. Jeff Stettler, USN.

The 1985 discovery of the wreck of the *Titanic* sparked a new round of forensic investigation. The bow section was found largely intact with the stern section in hundreds of pieces approximately 2,000 feet away. The realization that *Titanic*'s hull had broken at some point during the sinking added a new mystery to the already famous disaster. Fortunately, the discovery of the wreck also provided new forensic evidence in the form of recovered artifacts and detailed surveys. It was these new clues and advances in computer-driven engineering tools that dawned a new era of investigation.

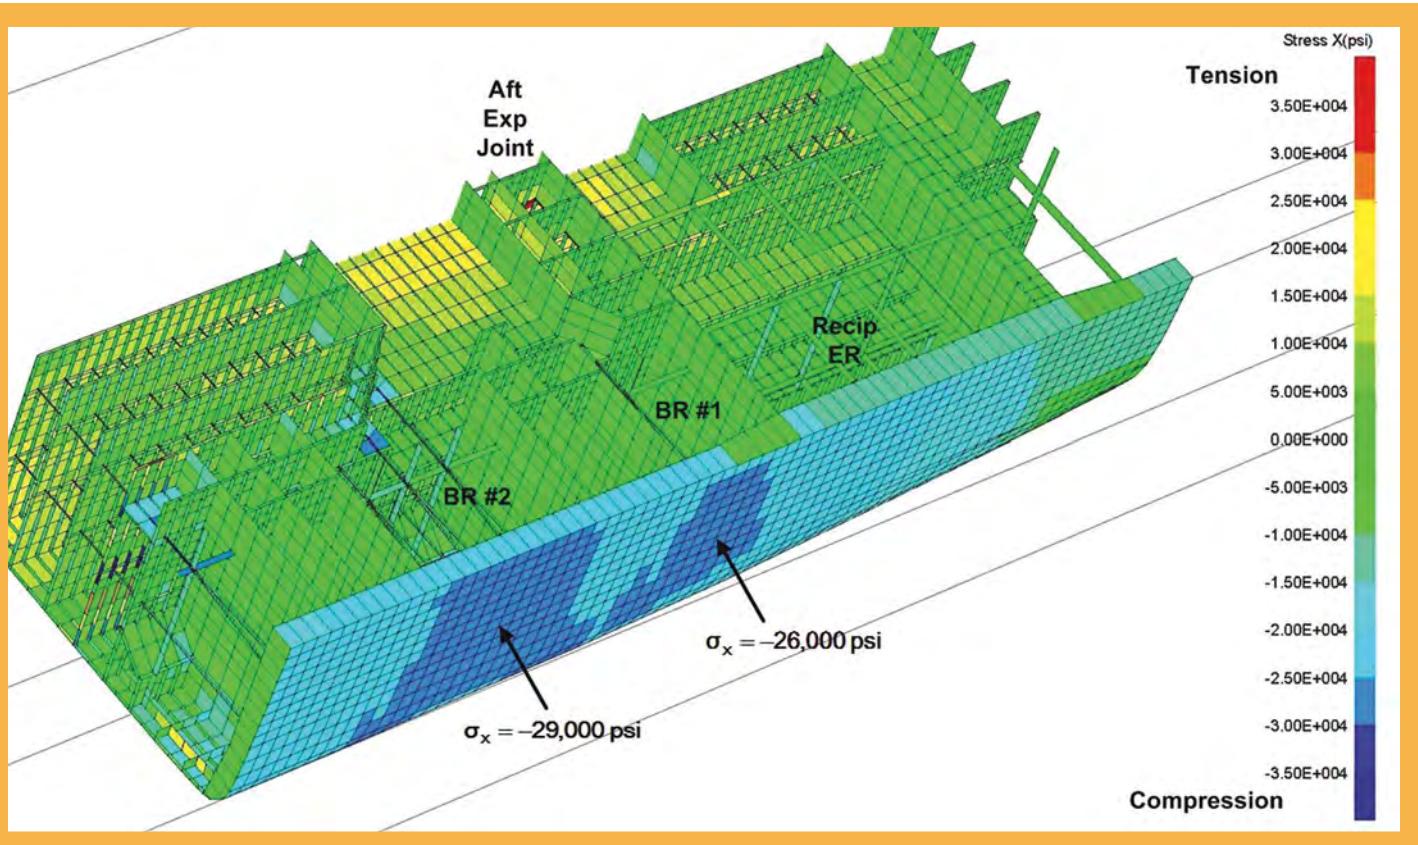
Finite element model of the *Titanic* shows stress in the bottom plating.

In 2003, Dr. Jennifer Hooper published a study that shed new light on the metallurgy of the hull steel and the wrought iron rivets, and their role in the sinking. Hooper and her co-authors were able to obtain wrought iron from the *Titanic*, as well as wrought iron samples from the same era used for other applications.

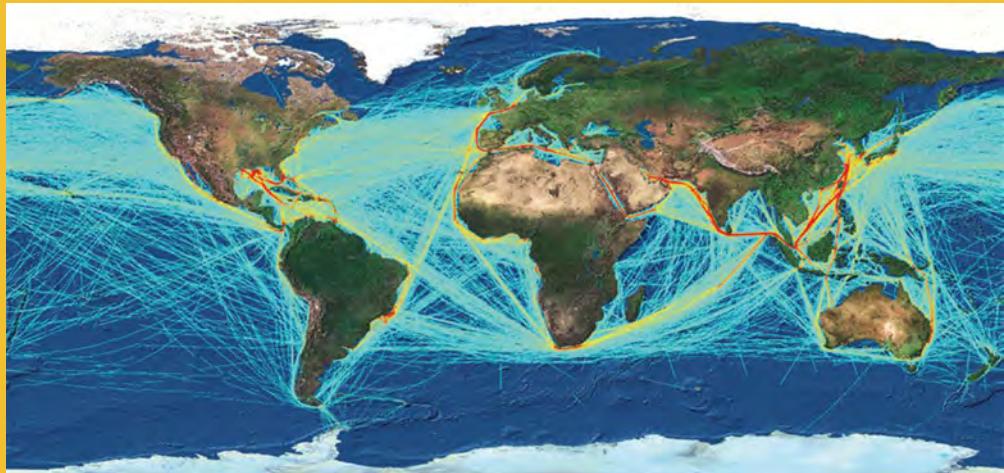
The Amver density plot. Depicts Amver participant activity worldwide for the month of December 2011.

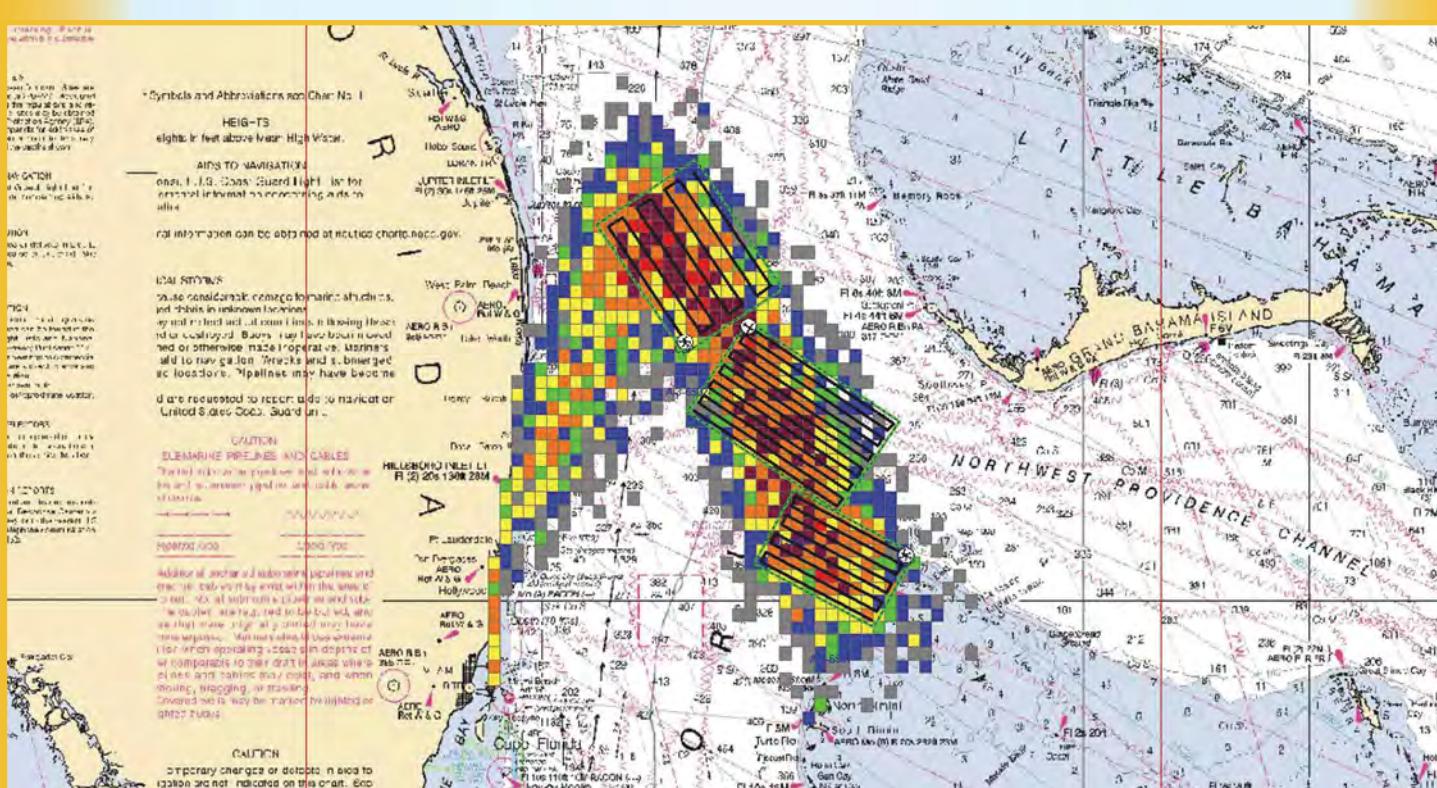
The Search and Rescue Optimal Planning System (SAROPS) is a state-of-the-art computer-based search planning tool used to estimate where those in distress may be located by using near-real-time environmental data. The depicted search was planned for two survivors after a helicopter was reported overdue between Miami and Bimini. The hot colors represent more probable locations of survivors.

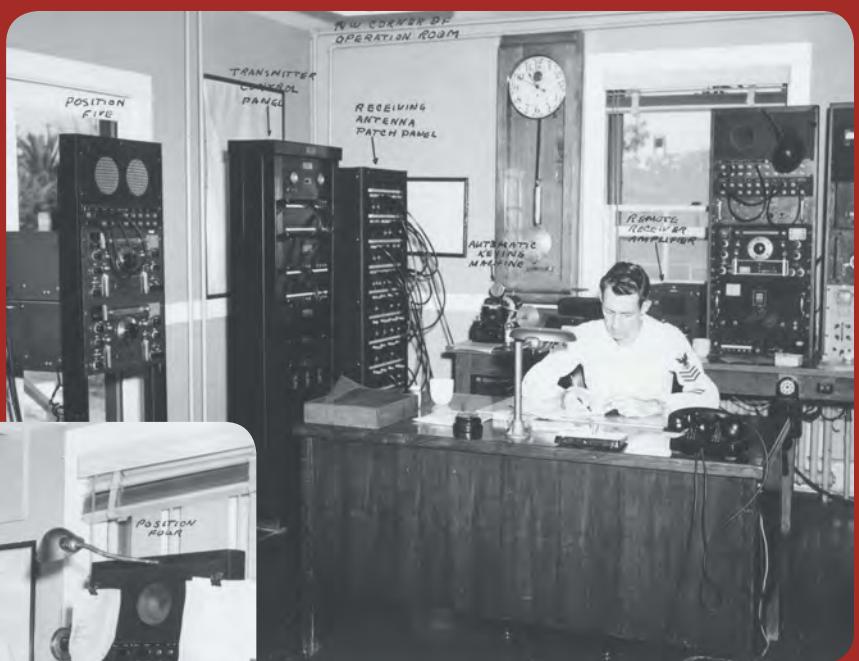
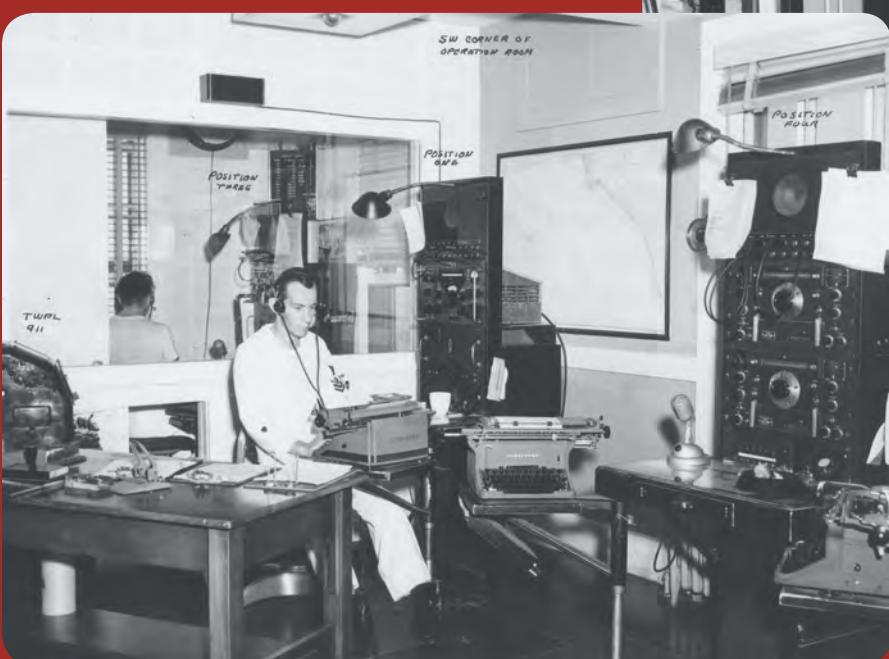
The operations room at USCG Radio Station Long Beach (left).

The radio operator monitors the international distress and calling frequency and operates the TWPL, which connected the station to the district headquarters. Through the glass is another radio operator monitoring another distress frequency and making all voice broadcasts.

Position four (the unmanned position) appears to be a combination voice/Morse position; two variable receivers, a patch panel, and speaker are visible.

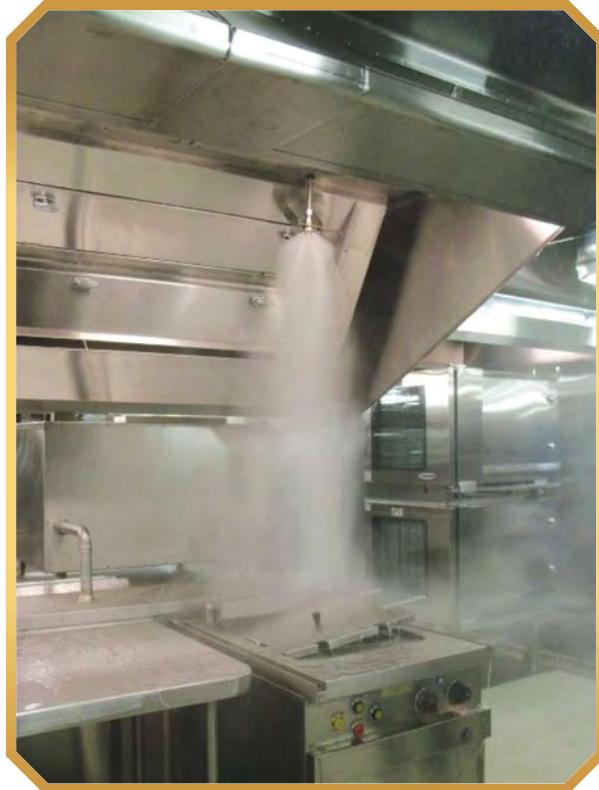
Galley water mist system test.

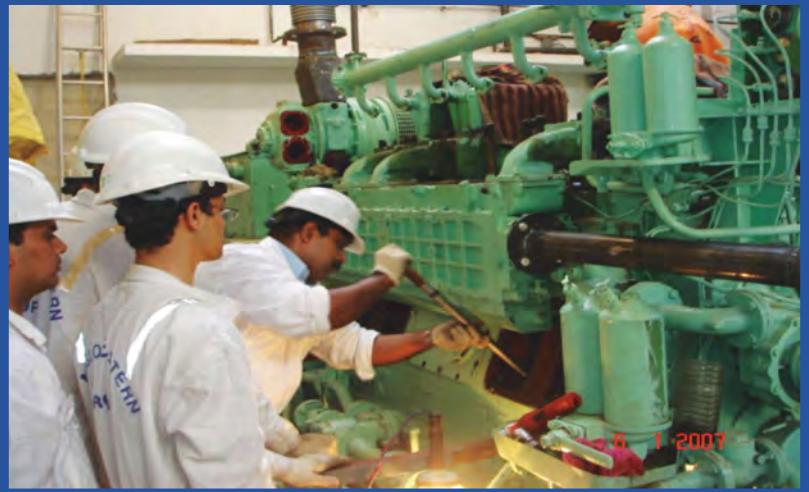
Anglo Eastern Ship Management's diesel engine maintenance module. Photos courtesy of Anglo Eastern Ship Management.

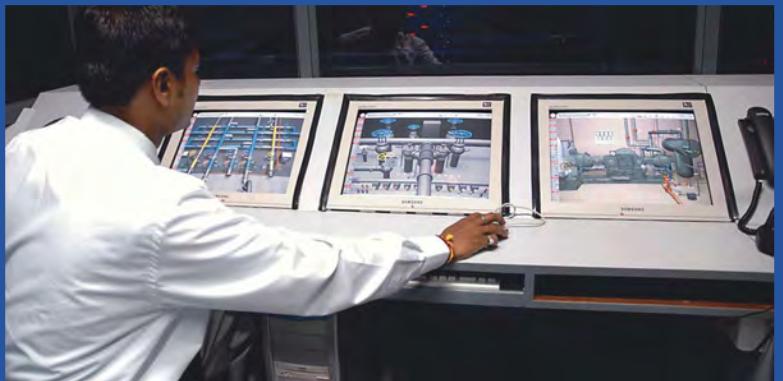
An instructor programs the control station to introduce tasks and problems for simulation exercises.

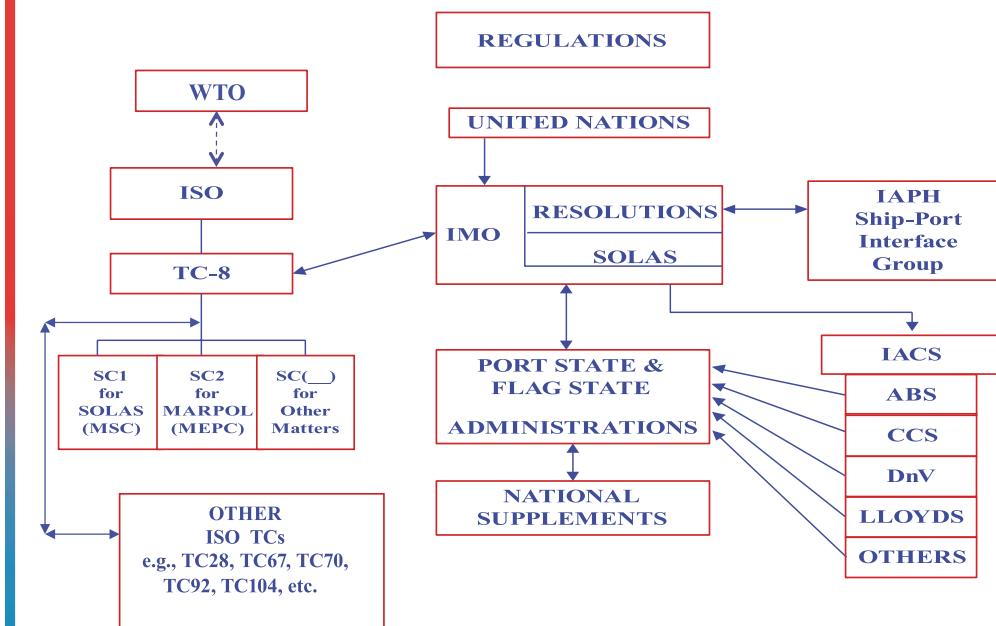
The organizational relationships among the ISO, international and national regulatory bodies, and recognized organizations commonly authorized to carry out certain vessel inspection functions on behalf of governments.

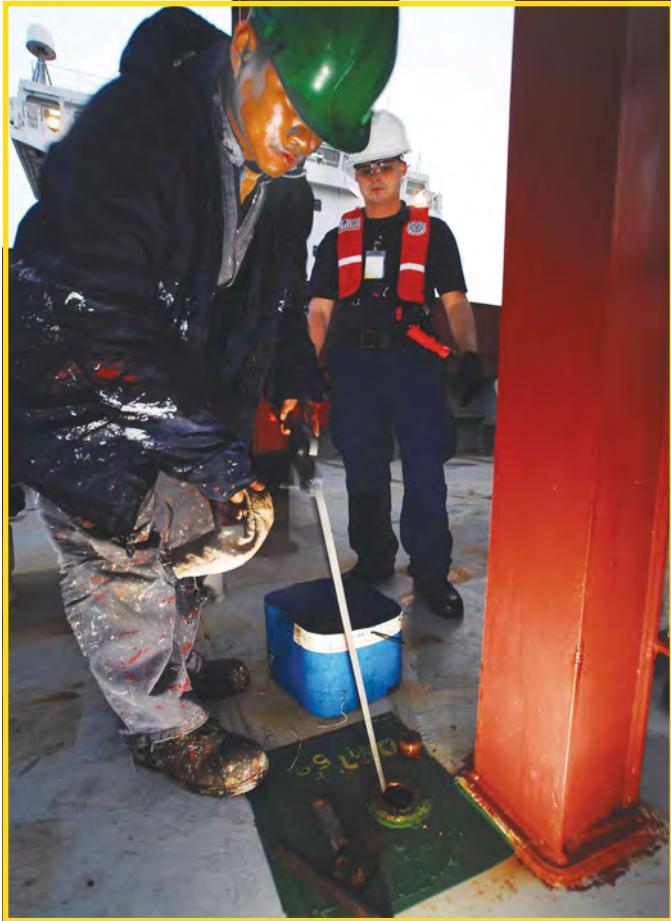
Ballast water sampling. The Ballast Water Convention is one of IMO's latest environmental protection measures. U.S. Coast Guard photo.

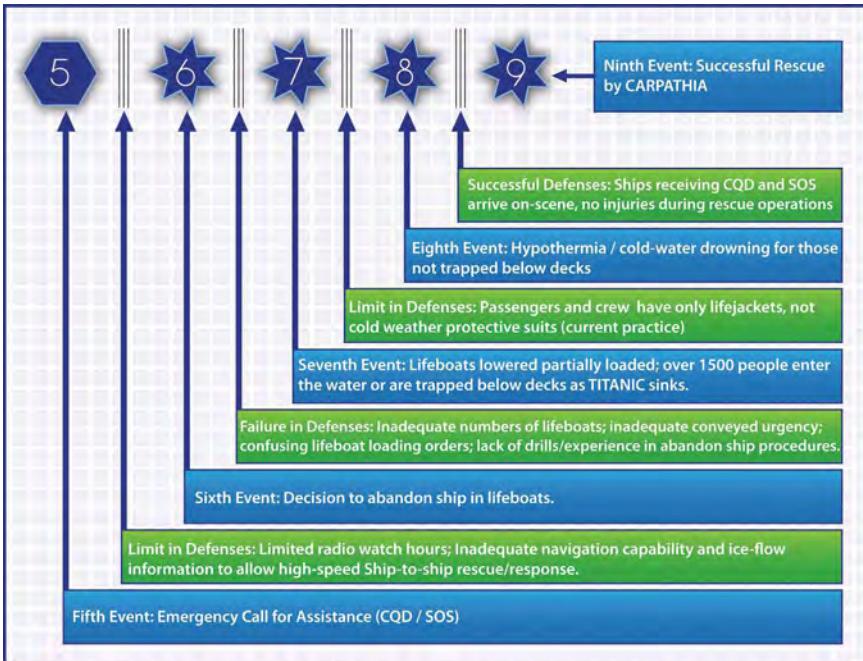
Figure 2. *Titanic's* defenses are inadequate to prevent disaster.

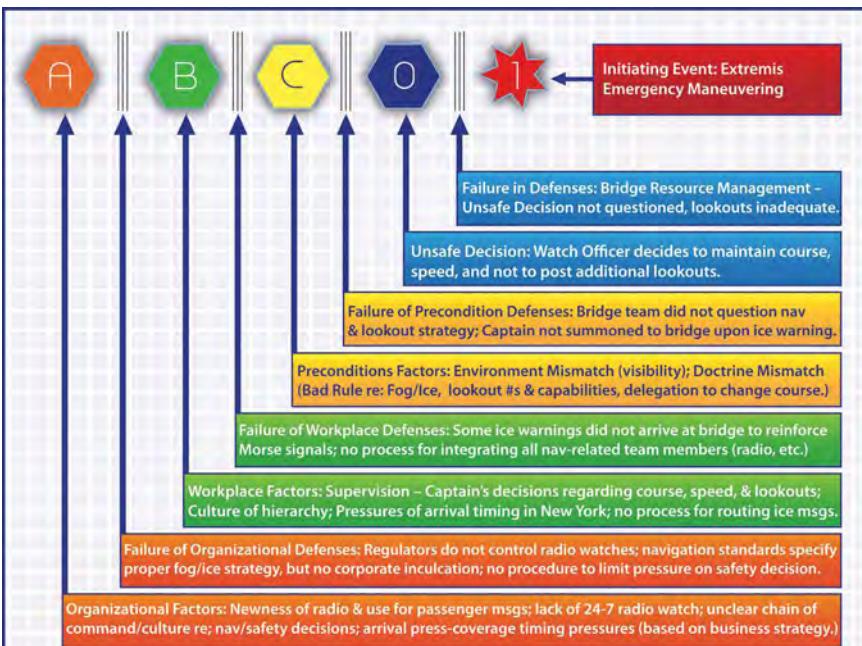
Figure 3. The human, procedural, and mechanical elements that contributed to the incident.
